# Low Velocity Impact Damage Analysis in Plain Weave Woven GFRP Laminates Through Optical and SEM Microscopy

M. A. Kounain, Z. Khan, F. Al-Sulaiman, N. Merah

**Abstract:** In the present study, instrumented drop weight impact tests at different impact energies were performed to investigate the modes and mechanisms of the low velocity impact damage in plain weave woven glass fiber reinforced plastic (GFRP) composite laminates. 8-ply, 16-ply, 24-ply and 32-ply laminates having identical  $0^\circ$  layup were examined via optical and scanning electron microscopy after free falling weight single bounce impacts. It was found that under low velocity impact the failure was initiated by matrix cracking at the interstitial region of  $0^\circ$  GFRP composite laminates. These matrix cracks were much extensive in 8-ply laminates as compared to laminates with larger number of plies. These matrix cracks propagate to cause fiber fracture and fiber matrix debonding and extend across the thickness of the laminate to introduce delamination. The eventual failure thus occurs through the combination of matrix cracking, fiber fracture, fiber matrix debonding and delamination.

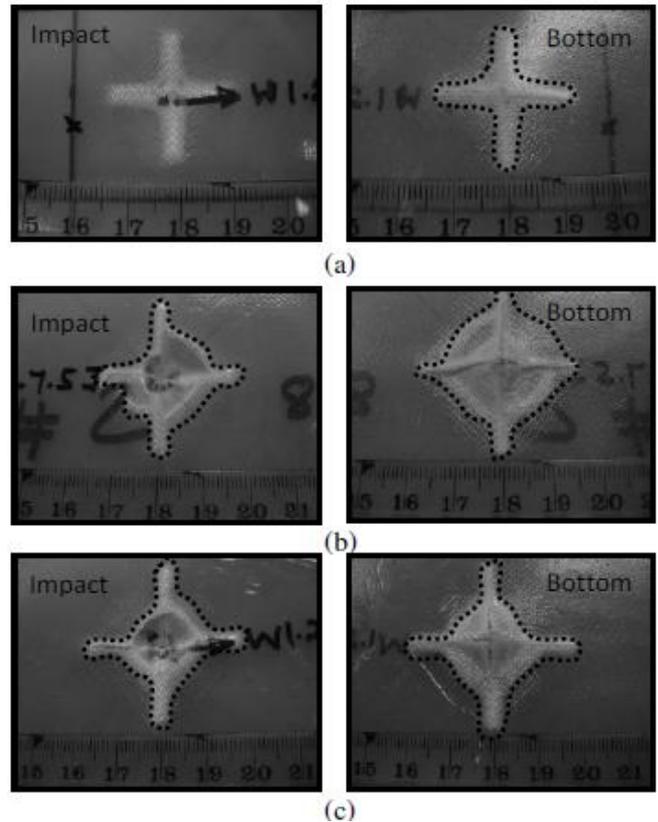
**8-Ply Laminates:** Images of impact damage areas developed at different impact energies on the front (impacted) and the back (rear) side of [0<sub>o</sub>]<sub>8</sub> laminates are shown in Figure . It is observed that the damage area increases with the increase in the impact energy. Unlike non-woven composite where the impact damage assumes a peanut shape, an X-shaped damage developed in the woven GFRP laminates as observed in Figure 2. The end points of the X-shaped damage seem to lie in the warp and weft strand directions. The region near the impact point on the composite exhibits fiber crushing (see Figure 2). This localized deformation is due to the high compressive stress generated close to the point of impact. At higher impact energy the [0<sub>o</sub>]<sub>8</sub> laminates exhibit uniform deformation by the formation of dome shape as shown in Figure (c). Micrographs of impact damage at various magnifications taken using SEM are shown in Figure and Figure 4.

**Figure 1. Impact and bottom side of the damage surface of [0°]<sub>8</sub> Specimen impacted at (a) 5J (b) 7.5J (c) 10J**

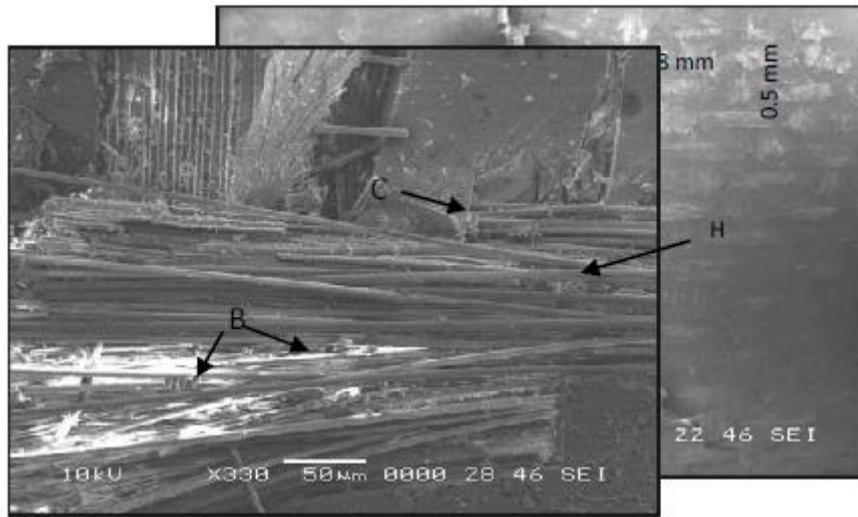
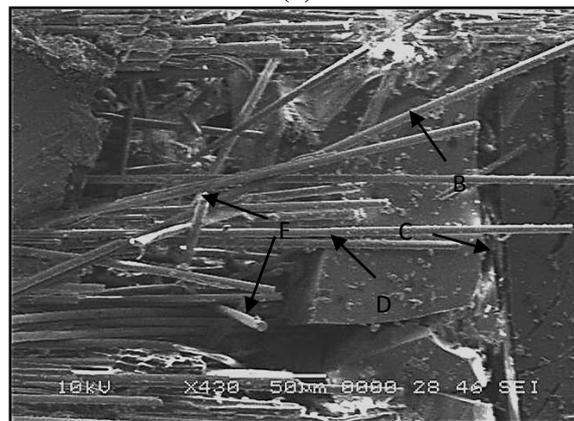
These SEM micrographs show that the major failure in the laminate occurs through mode II delamination i.e. in a non-penetrating impact load are fiber/matrix interface debonding and matrix cracks (fracture of matrix) as observed in Figure2 (b), (c) and **Figure** (a). Shear stress developed due to impact load drives debonding and the delamination initiates from micro-cracks originating from the regions of fiber debonding.

**Figure 2. SEM micrographs of  $[0^\circ]_8$  specimen impacted at 5J showing Hackles (H), Matrix Cracking (C), Debonding (B), Fiber Fracture (E) and Delamination (D)**

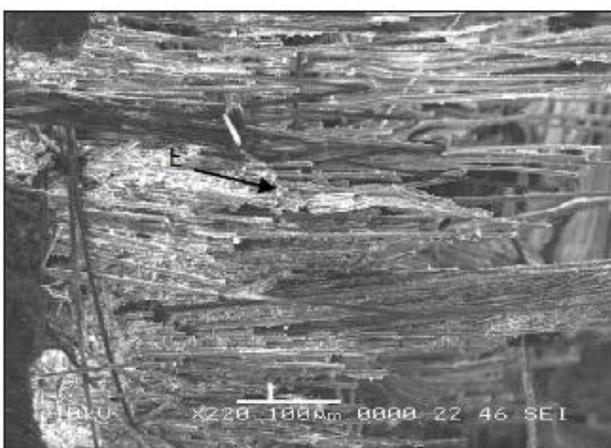
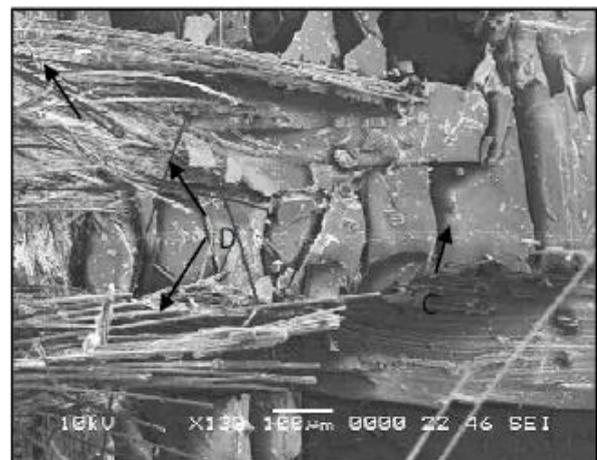
Another impact damage mechanism the *fiber fracture* is observed in **Figure** and Figure . Fiber fracture/breakage when the material is impacted with a higher impact energy/load, higher stresses are developed in the material

occurs when the impact load is sufficient to create stresses exceeding the fiber flexural strength. So which implies higher damage i.e. the amount of fiber fracture increases with the increase in impact energy.

**Figure 3. SEM micrographs of  $[0^\circ]_8$  specimen impacted at 7.5J showing Fiber Fracture (E), Delamination (D), Matrix Cracking (c)**

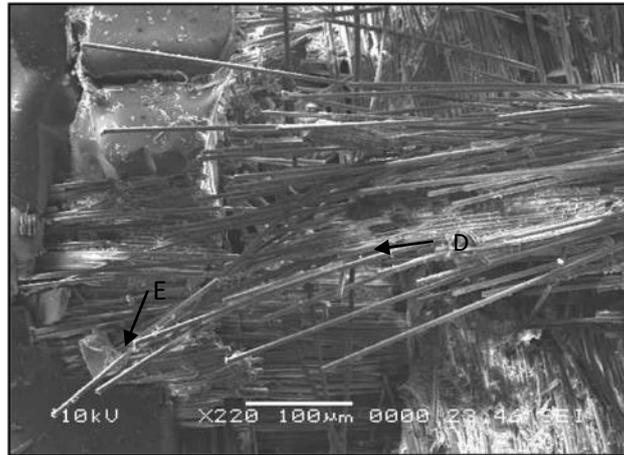
Figure 4. SEM micrograph of [0°]8 specimen impacted at 10J.

Looking at the above SEM micrographs it is understood that fiber pull out is the major mechanism to absorb the impact energy. As the impact crack propagates, glass fibers are

pulled out into loading direction and much impact energy is dissipated through this process.

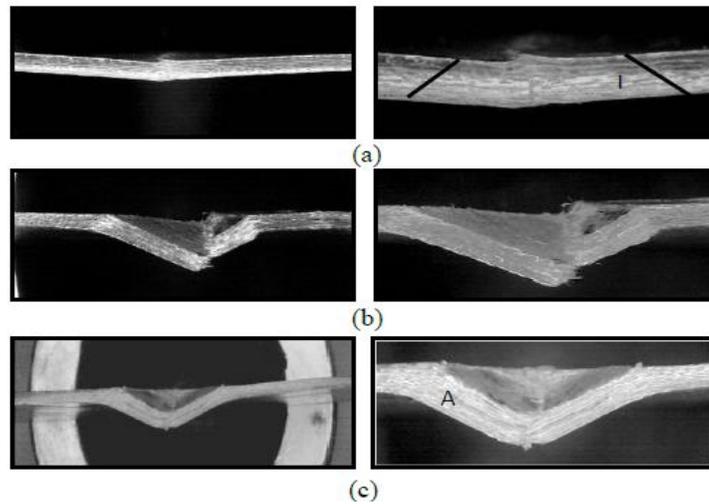
To determine the characteristic damage state, the impacted [0°]8 specimens were sectioned through the impact location in the direction parallel to the 0° fibers and observed under a low magnification microscope as seen in Fig. . As the impact energy increases the amount of deformation (curvature) extending through the thickness and the delamination (A) increased. A cone shape in the thickness

direction with the in-plane damage area increasing from the impact surface to the bottom side is also observed. At 5J impact energy a nearly undamaged zone is visible inside this conical shape. At the bottom surface, the laminate suffers bending stress, which results in delamination and fiber failure.

**Fig. 6. Optical micrographs of polished cross sections of the center of impact for  $[0^\circ]_8$  specimen impacted at: (a) 5J (b) 7.5J (c) 10J, depicting pine tree (L) and Delamination (A)**

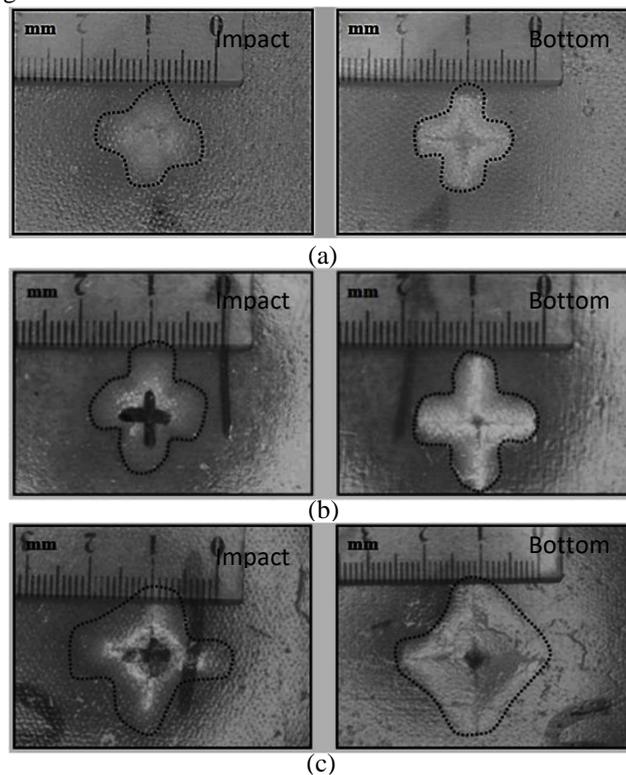
**16-Ply Laminates:** Images of impact damage areas developed at different impact energies on the impact side and the bottom side of  $[0^\circ]_{16}$  ply are shown in Figure 71.

**Figure 71. Impact and bottom side of the damage surface of  $[0^\circ]_{16}$  specimen impacted at (a) 5J (b) 7.5J (c) 10J**

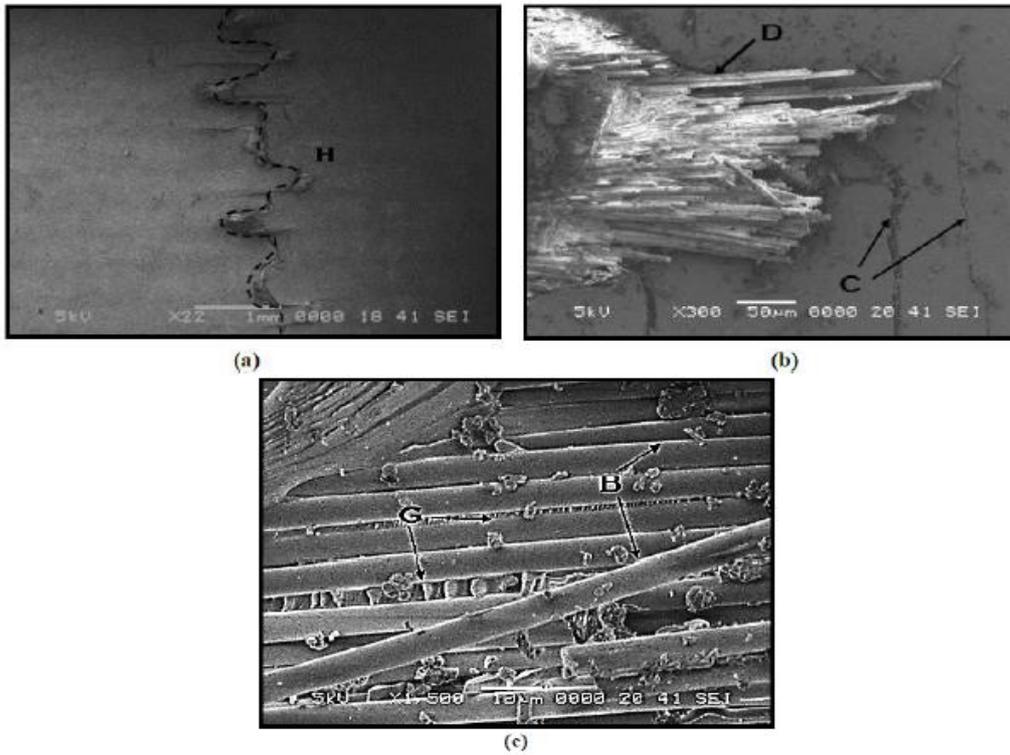
The progress of *crack* propagation at the bottom face of the specimen can be observed in Figure8 (a), which is schematically illustrated in Figure. Crack propagation in woven fabric composites considering its geometry is known to be rather complex when compared to that of non-woven unidirectional composites [Error! Reference source not found.]. In woven composites crack propagates parallel and as well as perpendicular to the fiber direction. The crack

Figure 8. SEM micrographs of  $[0^\circ]_{16}$  specimen impacted at 5J depicting Fiber-Resin Debonding (B) Hackles (G).

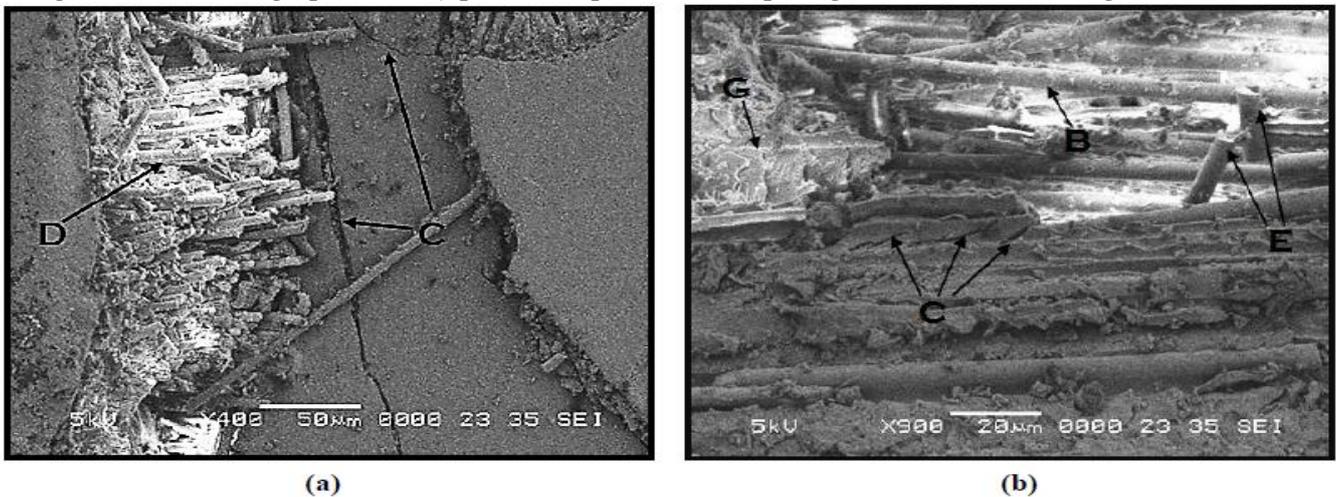
Figure 9. SEM micrograph of  $[0^\circ]_{16}$  specimen impacted at 7.5J depicting Fiber-Resin Debonding (B), Matrix Crack (C), Fiber Fracture (E) and Hackles (G).

SEM micrographs in Figure (c), Figure 9 (b) and Figure (a, b) shows the formation of *hackles* at the fiber-matrix interface. During mode II shear deformation, as shown in Figure 11 each end under shear stress deforms in opposite direction, which leads stress to concentrate at the fiber-matrix interface, and as this stress increases a micro-crack is formed at the crack front in case if the interface is strong

The major failure mechanisms *debonding* and *fracture of matrix* (matrix cracks) are observed in SEM micrographs shown in Figure 9 and Figure (c) as well as increasing amount of *fiber fracture* with the increase of impact energy is observed in Figure 9 (b) and Figure (a). Bare fibers with little resin attached to them are separated from each other as the impact energy increased to 10J as seen in Figure (a), caused due to fiber-matrix debonding which also lead to extensive fragmentation of the matrix (*matrix debris*). The cross section view of impacted  $[0^\circ]_{16}$  specimen is shown in Figure. The warp and weft woven fibers did not restrict the

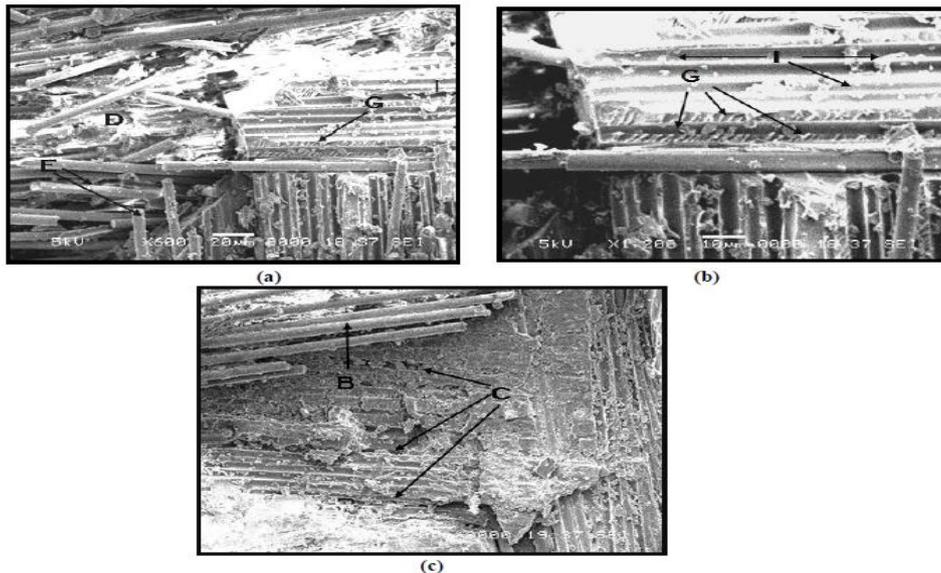
enough to endure the applied shear stress, and when the maximum effective stress at crack tip reaches the critical value, the micro-crack coalesce to form macro-crack and the macroscopic crack advances leading to *shear band* commonly known as *hackles* [13] as observed in this study. The formation of *hackles* increases with the increment of impact energy as observed from these SEM micrographs.

Figure 12. SEM micrographs of  $[0^\circ]_{16}$  specimen impacted at 10J.

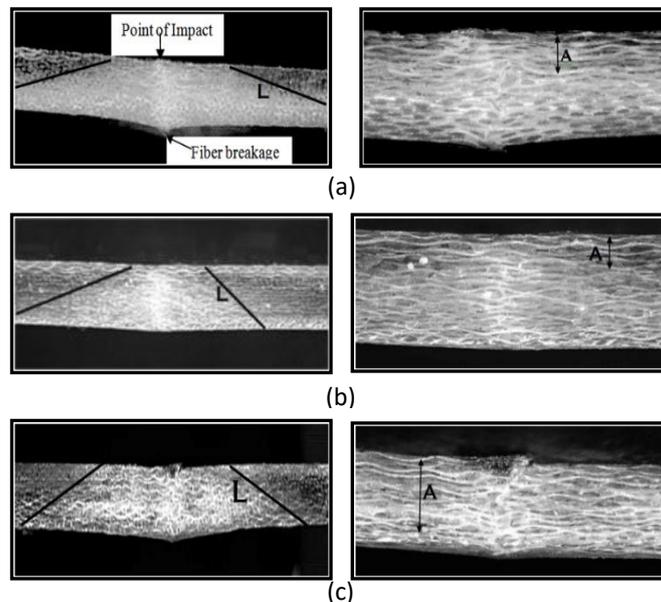
formation of a cone-shape delamination zone (contrasted as white color) with increasingly extensive damage towards the bottom face as seen in Figure. The cone-shape delamination zone has been observed in various studies on non-woven composite laminates, but a similar phenomenon was also observed for woven-fabric composites. The cone or also known as the *pine tree* damage pattern comprised of delamination and had its apex at the top (near the point of impact) as shown in Figure (a) and a widening base through the thickness of the laminate as also shown schematically in Figure 14.

Figure 13. Optical micrographs of polished cross sections of the center of impact of  $[0^\circ]_{16}$  specimen impacted at: (a) 5J (b) 7.5J (c) 10J depicting pine tree (L) and Delamination (A)

Fiber breakage at the bottom face of the specimen is noticeable in Figure 13(a) which results due to the tensile forces from bending. This process will continue with the increase in impact energy until complete perforation of the specimen occurs [Error! Reference source not found.]. The increment of the delamination depth is clearly evident with the ascending of the incipient impact energy on the specimens as shown in Figure (a)-(c).

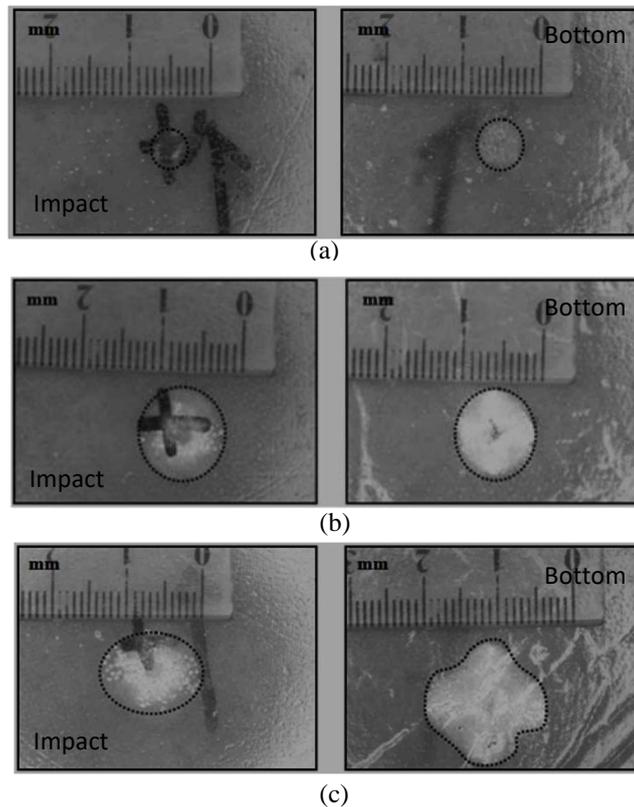
there is significant decrease in the delamination area as seen in Figure. The impact damage of  $[0^\circ]_{24}$  specimen impacted at 5J as shown in Figure (a) is hardly visible on the impact side, therefore the internal delamination area of this specimen is lowest of all as shown in **Error! Reference source not found.** As the damage of  $[0^\circ]_{24}$  specimen impacted at 5J was negligible, the SEM observation was unable to show any significant information. Mode-II shear failure is observed for the  $[0^\circ]_{24}$  specimens subjected to 7.5J of impact energy leading to debonding as observed from Figure. With the increase of impact energy the crack growth on the bottom ply can be seen in Figure (a). Unlike to  $[0^\circ]_{16}$  specimen, formation of hackles in a  $[0^\circ]_{24}$  specimen was considerably less at 10J impact energy as seen at higher magnification as shown in Figure possibly due to weak fiber-matrix interfacial strength [Error! Reference source not found.] which lead to fiber-matrix debonding which remains as major failure mechanism at this stage as seen in Figure (b).

**Figure 14. Impact and bottom side of the damage surface of  $[0^\circ]_{24}$  specimen impacted at (a) 5J (b) 7.5J (c) 10J**

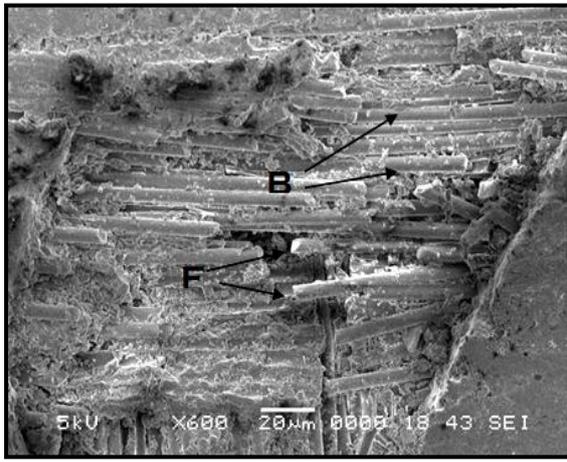
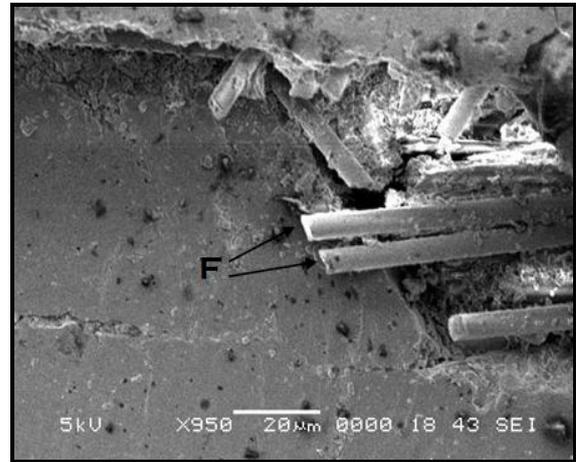
Figure 15. SEM micrographs of  $[0^\circ]_{24}$  specimen impacted at 7.5J.

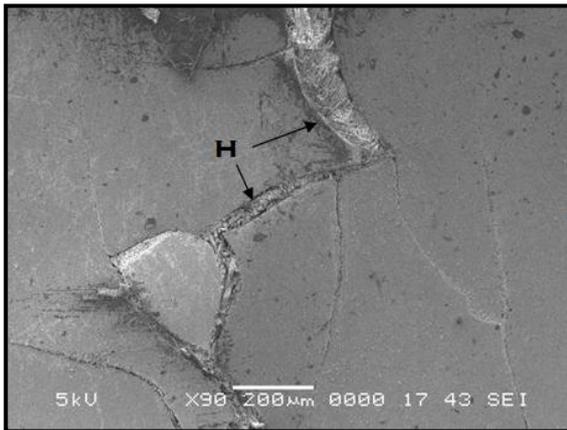
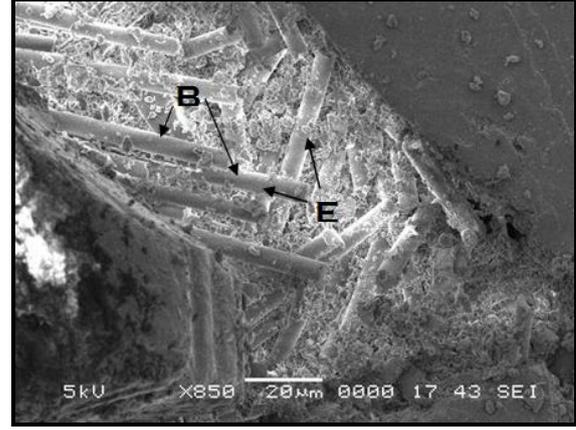
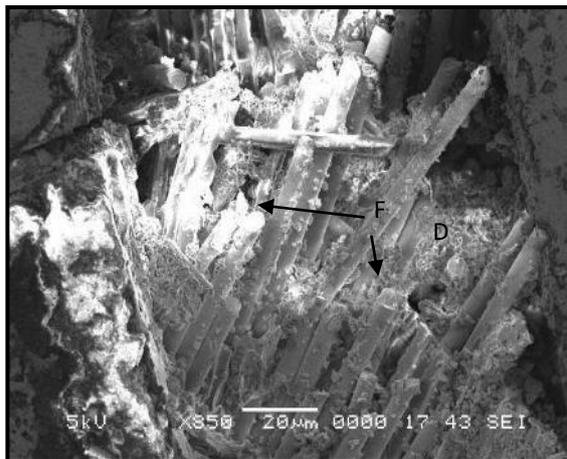
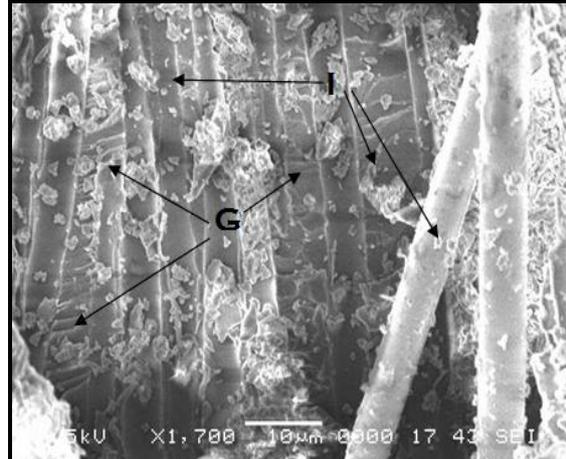
Figure 16. SEM micrograph of  $[0^\circ]_{24}$  specimen impacted at 10J depicting formation of Hackles (G) and Debris of Resin (I).

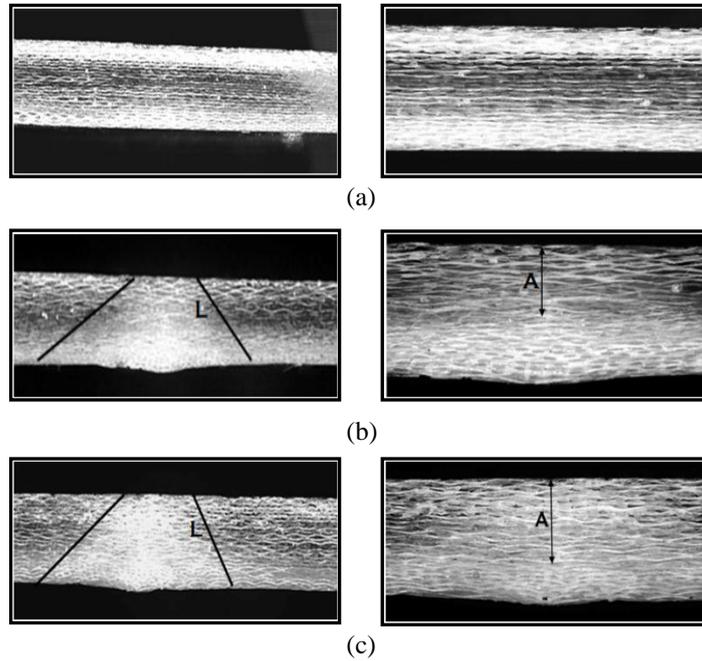
Figure 17. Optical micrographs of polished cross sections of the center of impact of  $[0^\circ]_{24}$  specimen impacted at: (a) 5J (b) 7.5J (c) 10J, depicting pine tree (L) and Delamination (A)

As learned before the damage at 5J impact energy was negligible, therefore *pine tree* damage pattern is not visible in the cross sectional view as seen in Figure (a) but later as the impact energy increased the progress of delamination is observed from Figure (b) and (c) within the cone of damage.

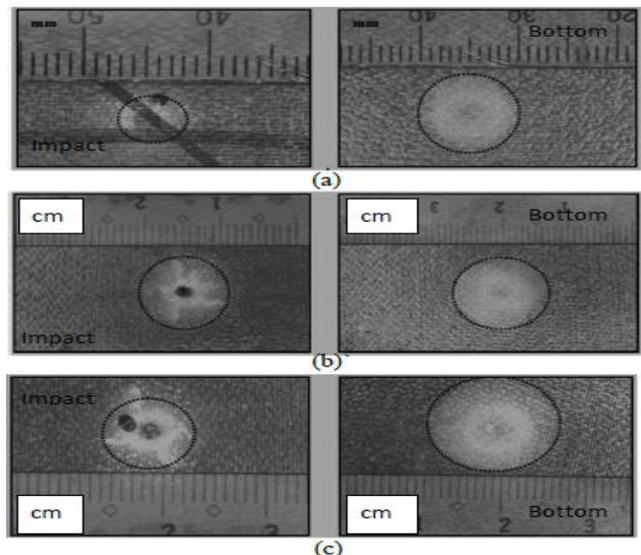
**32-Ply Laminates:** The images taken by low magnification microscope, showing the progress of impact damage at the front and bottom face of the  $[0^\circ]_{32}$  specimen with the increase of incident impact energy (see Figure). As can be observed the damage at the bottom face of the material is larger than that of the impacted side which could be explained as the delamination progress through the plies forming a cone of damage. The shape of the damage at the bottom face remains nearly circular.

Figure 18. Impact and bottom side of the damage surface of  $[0^\circ]_{32}$  specimen impacted at (a) 5J (b) 7.5J (c) 10J ply i.e. 32<sup>nd</sup> ply. Observing the local damage areas at higher magnifications, one could observe the fiber failure at the bottom ply and local delamination between the outer (lowest) and the inner ply (see Figure), and as the impact energy was increased to 10J the failure of the fibers at the outer ply increased as seen in Figure.

Unlike the 16 and 24 ply specimen, damage at the bottom side of 32 ply specimen didn't show the formation of crack (as seen in Figure (a) and Figure (a)), instead small local damage areas were formed at all impact energies used. The reason could be related to the incident impact energy being unable to cause much of the delamination reach the lowest

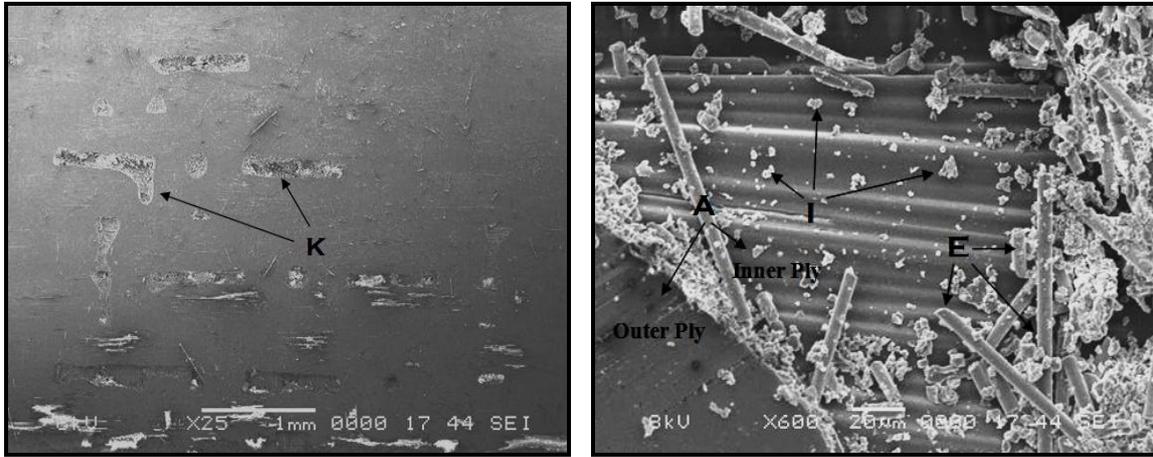
(a) (b)  
Figure 19. SEM micrographs of  $[0^\circ]_{32}$  specimen impacted at 5J.

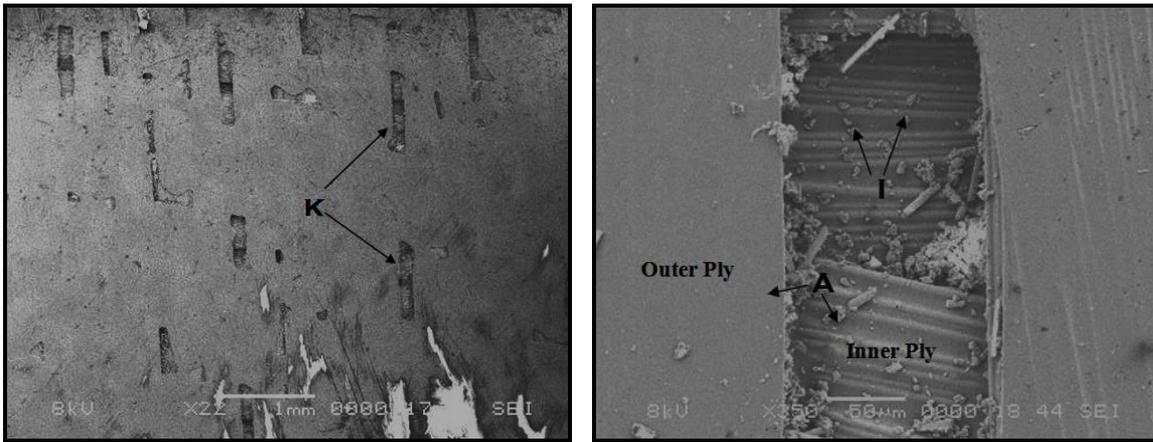
(a) (b)  
Figure 20. SEM micrographs of  $[0^\circ]_{32}$  specimen impacted at 7.5J.

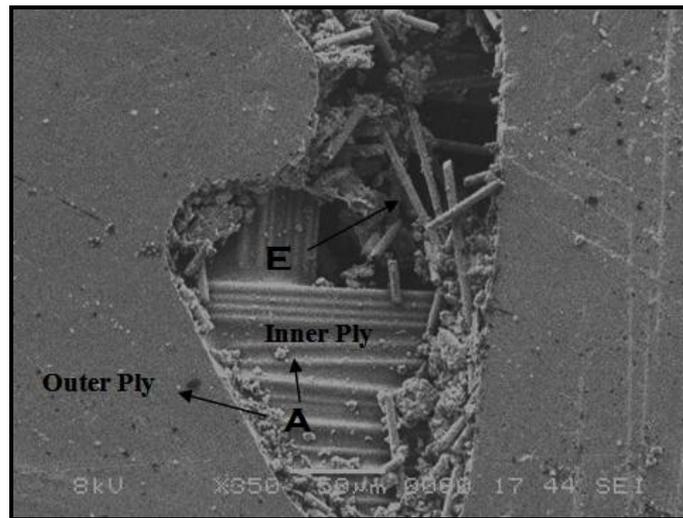
Figure 21. SEM micrograph of  $[0^\circ]_{32}$  specimen impacted at 10J.

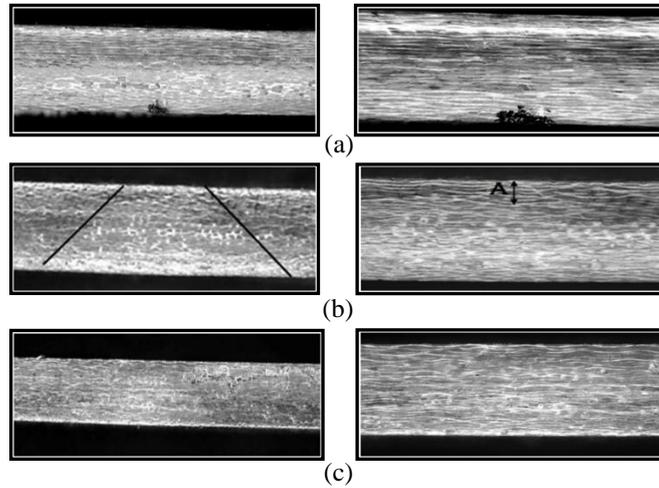
**Figure 22. Optical micrographs of polished cross sections of the center of impact of  $[0^\circ]_{32}$  specimen impacted at: (a) 5J (b) 7.5J (c) 10J, depicting pine tree (L) and Delamination (A)**

The cross section view of impacted  $[0^\circ]_{32}$  ply specimen, shows very little amount of delamination and even the progress of delamination through the thickness is hardly visible (see Figure ). SEM and optical observations were unable to explain the phenomenon of internal damage to this specimen.
