Rock Slope Stability Assessment of Gunung Rapat Limestone Hills, Kinta Valley, Perak, Malaysia

Jihan Rufaidah Mustapha, Chow Weng Sum, Abdul Ghani Rafek

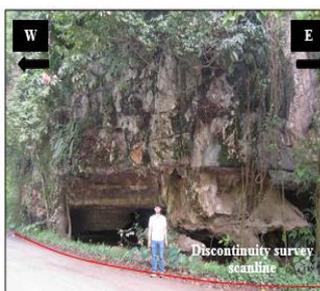
Fig. 5: Slope M3, iMix Quarry, Ipoh, Perak, Malaysia

The dip/dip direction of the slope face is $85^\circ/80^\circ$. There are potential plane and wedge failures identified on the eastern and south-eastern part of the stereonet while the potential toppling failure is identified on the western part of the stereonet.

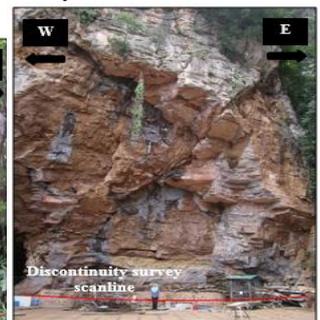
Fig. 6: Slope T1, Miaw Yuan Chan Lin Temple, Ipoh, Perak, Malaysia

The dip/dip direction of the slope face is $85^\circ/105^\circ$. There are potential plane and wedge failures identified on the eastern and south-eastern part of the stereonet.

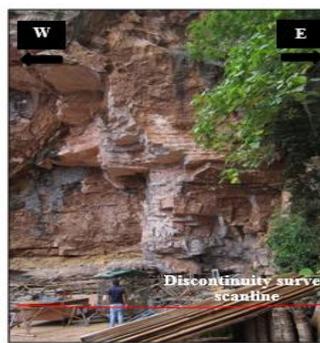
Fig. 7: Slope T2, Miaw Yuan Chan Lin Temple, Ipoh, Perak, Malaysia

The dip/dip direction of the slope face is 82°/ 95°. The shaded region shows the zone of critical area. There is one mode of failure identified, which is the wedge failure. There are also potential wedge, and plane failures on the eastern and south-eastern part of the stereonet while the potential toppling failure is identified on the western part of the stereonet.

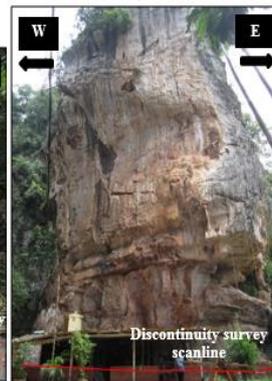
Fig. 8: Slope T3, Miaw Yuan Chan Lin Temple, Ipoh, Perak, Malaysia

The dip/dip direction of the slope face is 82°/ 124°. The shaded region shows the zone of critical area. There are two modes of failure identified, which are the plane and wedge failures. There are also potential wedge failures identified on the south-eastern and southern part of the stereonet.

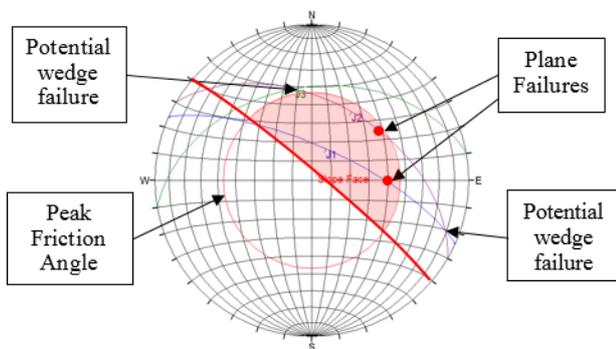
Fig. 9: Kinematic analysis for slope M1, using peak friction angle of 43° .

The dip/dip direction of the slope face is $85^\circ/40^\circ$. The shaded region shows the zone of critical area. The mode of failure identified is plane failure. There are also potential wedge failures outside the zone of critical area.

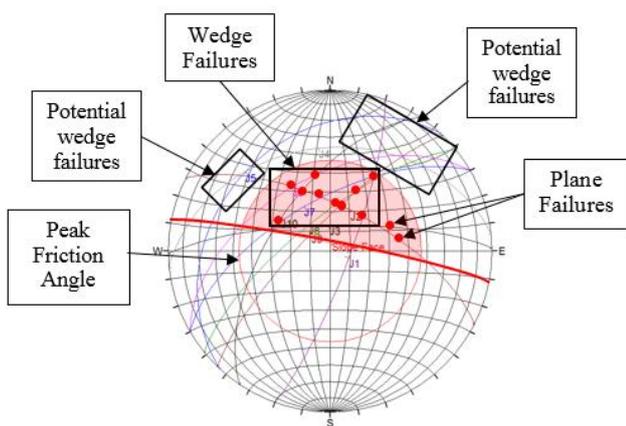
Fig. 10: Kinematic analysis for slope M2, using peak friction angle of 43° .

The dip/dip direction of the slope face is $85^\circ/11^\circ$. The shaded region shows the zone of critical area. The modes of failures identified are plane and wedge failures. There are also potential wedge failures outside the zone of critical area.

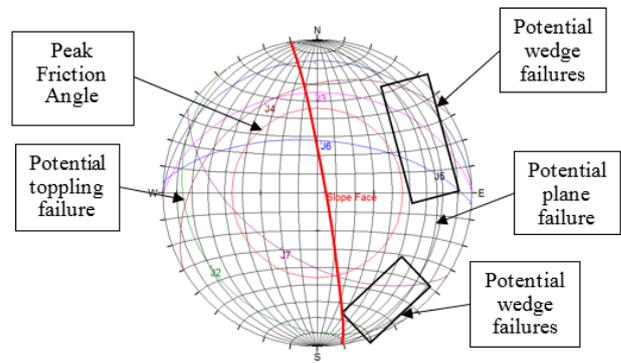
Fig. 11: Kinematic analysis for slope M3, using peak friction angle of 46° .

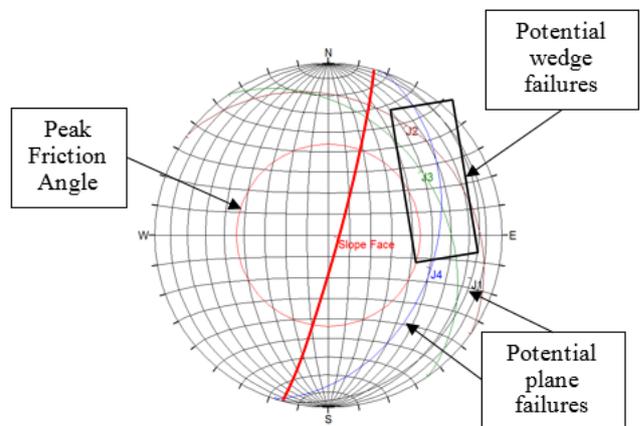
Fig. 12: Kinematic analysis for slope T1, using peak friction angle of 46° .

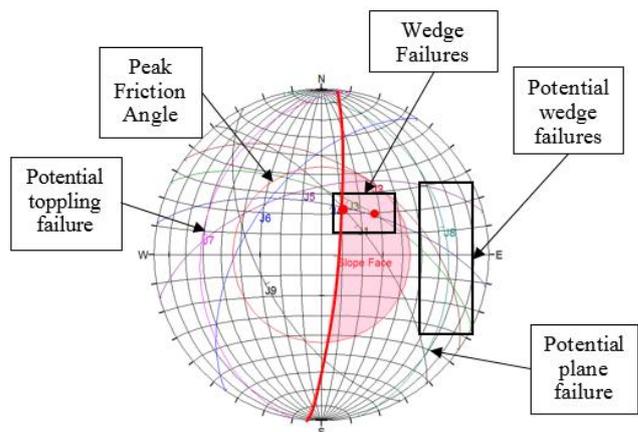
Fig. 13: Kinematic analysis for slope T2, using peak friction angle of 46° .

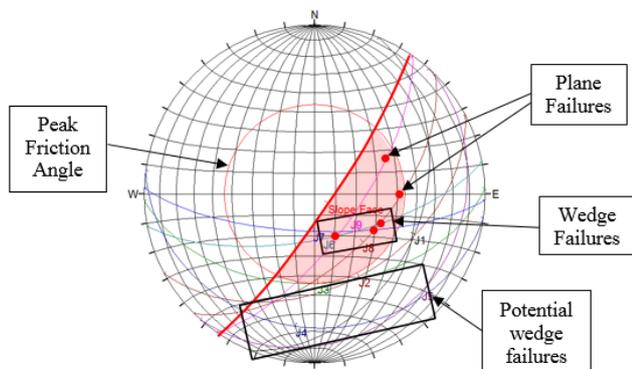
Fig. 14: Kinematic analysis for slope T3, using peak friction angle of 46°
