Retrofitting and Rehabilitation of damage footbridge over Yamuna River

Anjani Kumar Shukla, P R Maiti

Abstract: Every Structure has a certain predefined age with which it has to withstand, and after that, it requires the rehabilitation/repairing to avoid any damage or collapse. The footbridge over Yamuna River in Delhi, India was constructed in 1960 adjacent to Wazirabad barrage, and this is a very important link to East Delhi and West Delhi. Due to heavy traffic plying on this footbridge, in due course of time, the signs of deterioration were visible in the bridge expansion joint assemblies in the deck slab and cantilever portion of footpath slab. There were many potholes also developed in the wearing course. It was also dilapidation observed in many portions of the footpath, and some portion of the footpath slab were collapsed. The cantilever portion of the footbridge was retrofitted with steel jacketing fixing in the main longitudinal girder of the bridge. In this study analysis of the cantilever footbridge slab retrofitted by a steel jacket was carried out to check the deflection and stress limit of the bridge and it is found that the bridge is safe and now Bridge is open for

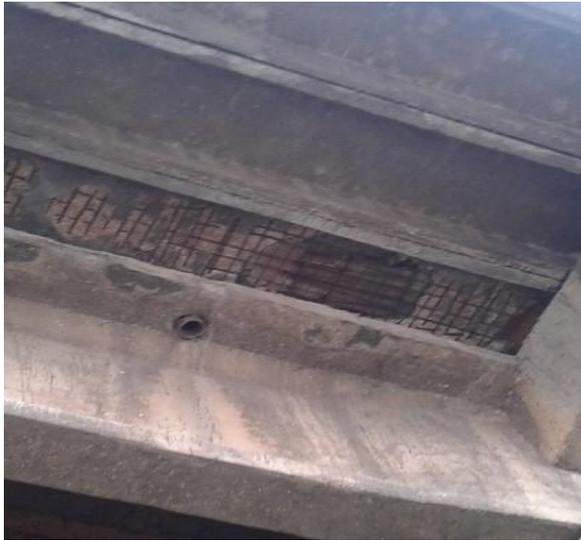
As damage to the footbridge slab can be seen in the Figure 4. The covering concrete had been scrapped at some extent and reinforcement also deteriorated due to salinity of water. So it was needed to replace urgently. Surface of footbridge also got damage due to excess loading can be seen in figure 4 as it become unserviceable. Figure 6 shows the brutally damage of reinforcement and footbridge slab due to salinity of water.

Figure 3 Bottom View of footbridge slab

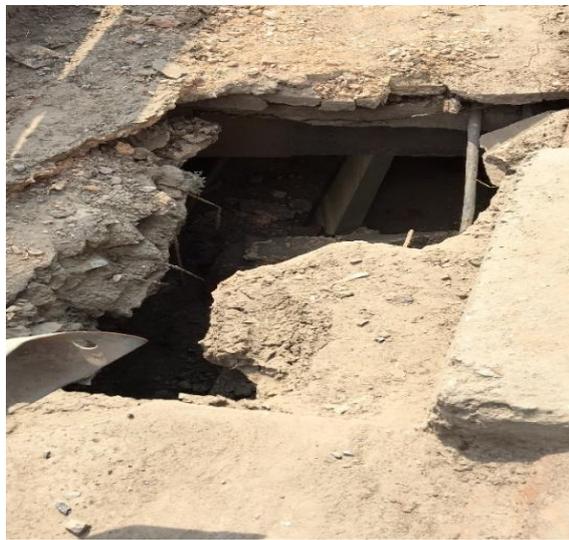
Figure 4 Top View of Slab

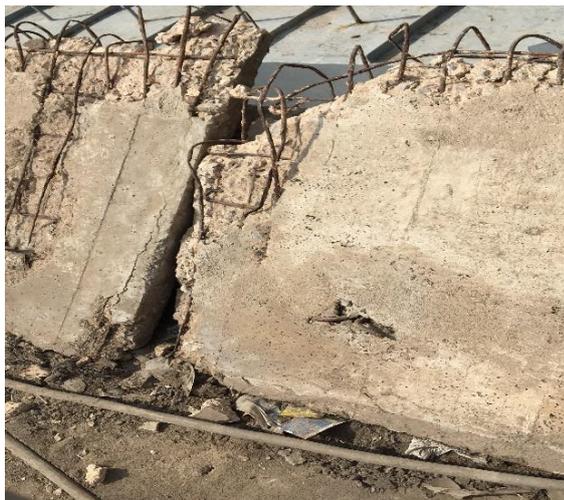
The footbridge has been damaged and become unserviceable (Figure 3 & Figure 4) due to overloading, material aging and salinity of water. The slab of footway was damaged at the extent from where repairing was not possible. The footbridge has been scrapped completely (Figure 5). After scrapping the damaged footbridge portion the rehabilitation of cantilever beam has been done by jacketing with steel. After jacketing the cantilever beam, the fabrication of deck slab was done by PPGI sheet as permanent shuttering and a fresh deck slab laid down (Figure 14).

Figure 5 Scrapped portion of deck Slab

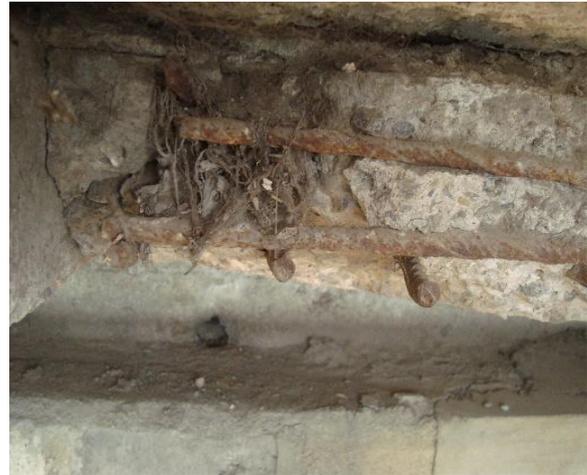
Figure 6 Deteriorated Reinforcement of slab

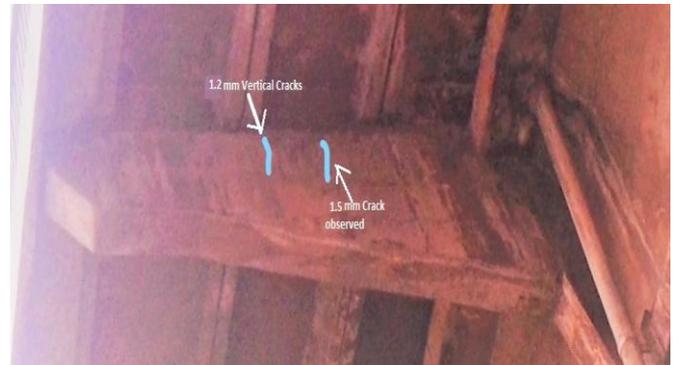
In the Figure 7 the cracks forms due to the Excess Loading and Aging can be easily seen. The several crack which is exceeding the standard limit can be easily observed.

Figure 7 Crack observed in the beam supported slab

There were many factors because of which cantilever beam deteriorated and crack can be easily seen in Figure 7. Like Aging, Water flowing below footbridge contains SO_4 and CL^- , Increased Traffic density. In this work the Steel Jacketing in both side of cantilever beam has been done Figure 8. The Modelling was done using the STAAD Pro. V8i (Figure 9).

As some cracks were observed in the cantilever beam supported to slab (figure 7) and slab of foot bridge was also damaged by water quality flowing below so to prevent in future a preventive layer of PPGI sheet also provided Figure 10 and 11. The Retrofitting of the existing footbridge slab was not possible without scrapping entire footbridge slab. So first entire slab was needed to scrap carefully. The IRC 6 suggested that if the crack in the cantilever beam is greater than 1mm under service load then it need to be strengthen immediately so to strengthen the cantilever beam steel jacketing of ISMB angles and plates section has been used (Figure 5 & Figure 6). The details are given below-

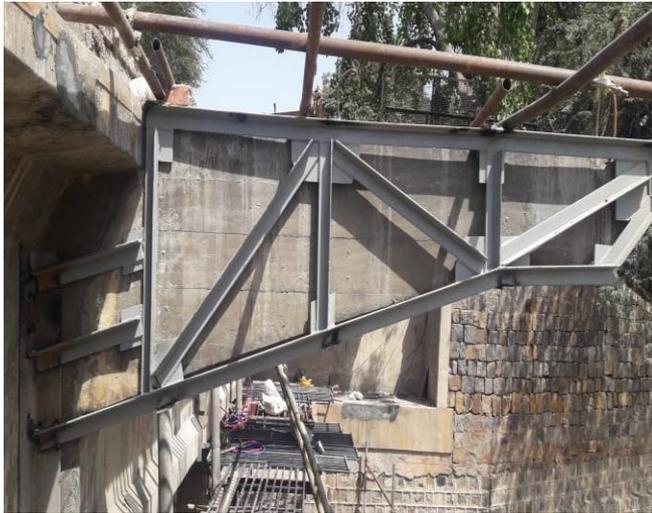
Figure 8. Jacketing of Cantilever beam of footbridge

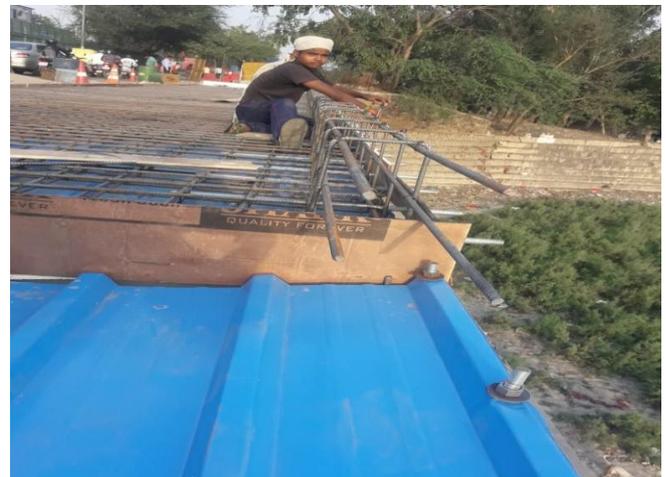
Figure 10 Laying of PPGI sheets

As specified in table 2, PPGI sheet were drawn below the deck slab to protect the Deck slab from the corrosion and deterioration from dangerous chemical in below flowing river Figure 10 and Figure 11. The sectional line diagram of deck slab can be observed in Figure 12.

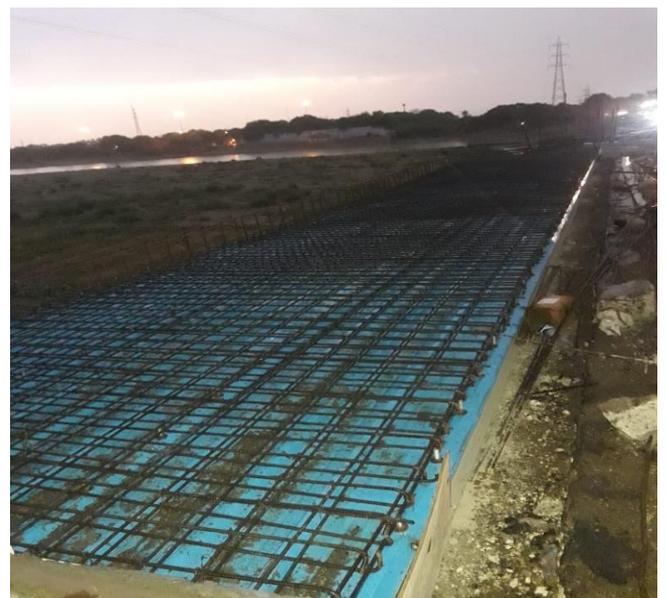
Figure 11 Skelton of steel for Deck slab

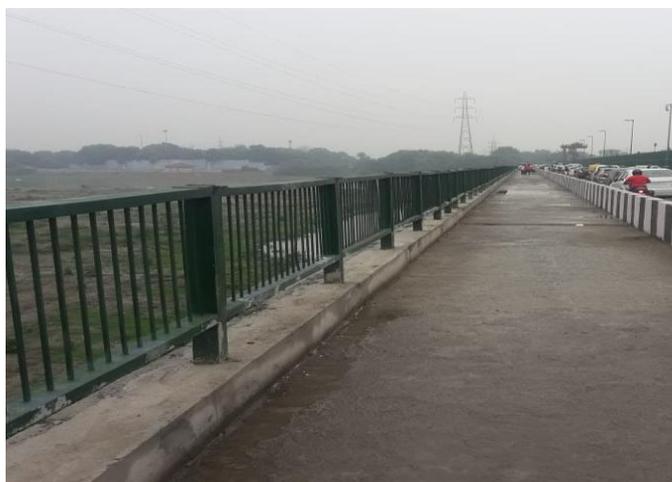
Figure 14 Final View of Retrofitted foot bridge Slab

1. The Maximum Resultant Displacement is 9.526 mm, which is in downward side.
2. The Maximum Horizontal Displacement in X direction is 4.957 mm.
3. The Maximum Axial Compressive Stress is -9.227 N/mm² in both steel beam which is fix with main girder of bridge and between node 22-26 and 3-10.
4. The Maximum Axial Tensile Stress is 21.824 N/mm² in Both steel beam which is fix with main girder of bridge and between Node 17-28 and 12-14.
5. Retrofitted footbridge were open for the traffic (Figure 14) when analysis steel jacketing members and found all safe.
