Conservation Measures for Improving Land Use and Land Cover in Dalvoy Lake Environs of Mysore City

Akshatha N, Shankar B

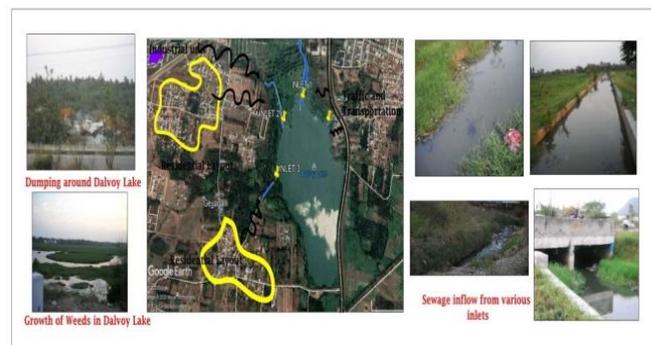
Figure 6 Land use around Dalvoy Lake

(A) **Discharge of Polluted water into Dalvoy Lake:** Dumping of building debris and discharge of untreated domestic sewage, industrial effluents into lake has contributed to low water quality resulting in loss of flora and fauna, pungent smell and finally aesthetics of the lake and its environs is lost. Figure 6 illustrates entry of pollutants and impact of different landuse on Dalvoy Lake.

Discharge of untreated domestic and industrial effluents into Dalvoy Lake pollutes the lake and contaminates ground water as well. Percentage of built-up area has increased around Dalvoy Lake due to growth of industrial sector, residential layouts namely JP Nagar and Siddalingeshwara layout, traffic and transportation infrastructure etc. Change of Land use and Land cover are the main contributors for pollution. Each land use contributes to different amount of pollution like (a) industries - discharge of heavy metals and detergents, (b) agriculture- use of harmful fertilizers, (c) commercial and residential units. Table 3 illustrates analysis of pollutants entering from various inlets into the lake.
