# Structural Integrity of "Gulmarg Gondola Project" using Modern Techniques

**Abstract:** NIT Srinagar was requested to carry out Non-destructive test of civil work of Gulmarg Gondola Project (cable car project) at Gulmarg (J&K) under J&K State Cable Car Corporation. So as to assess the present strength of R.C.C. columns of project the non-destructive testing of various columns along with condition survey was carried out to assess integrity of structural members. Investigation was carried out to check the concrete quality, corrosion in reinforcing bars and carbonation of concrete. The concrete quality was found out by using Ultrasonic technique and Hammer Rebound method. The carbonation was determined by use of Phenolphthalein test. The visual examination was carried to find out (locate) the dampness, cracks and other defects in the buildings. The purpose of the survey is to collect sufficient data to pinpoint the cause and source of the problem and to determine the extent of the damage. Durability of concrete is a function of the performance of concrete with respect to time in the service conditions. The concrete is said to be durable when it can withstand the conditions, for whi

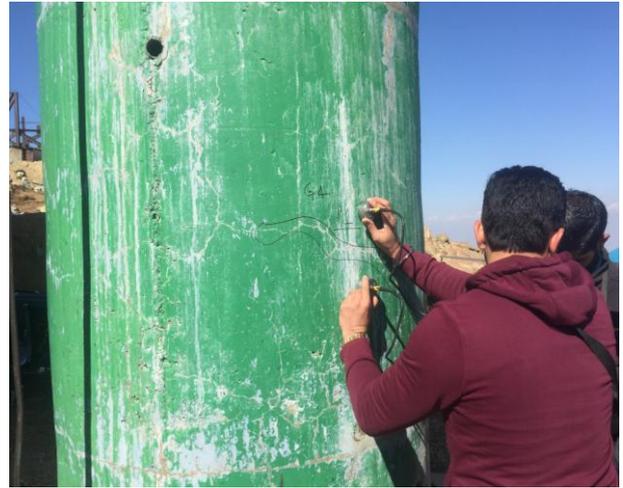
**Fig.3. Testing of Column using Ultrasonic Pulse velocity test to check the crack depth**

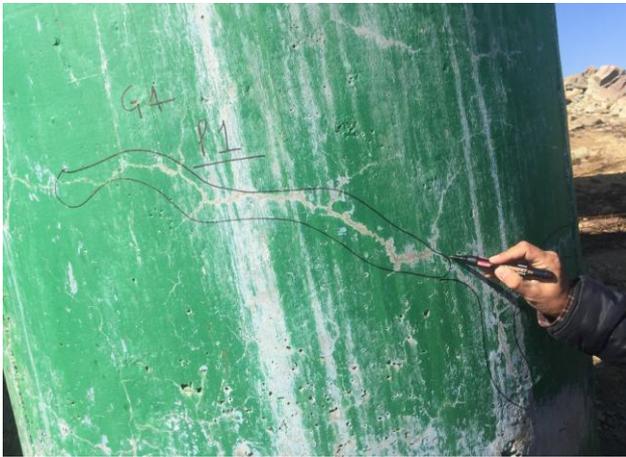
5. The superficial cracks were observed in columns of Tower T16, T15 and T14 (between G-4 and G-3).
6. Platform of T15 (between G-4 and G-3) is damaged to great extent and needs repair.

**Fig.1. Superficial cracks on Column P1 of Station G-4**

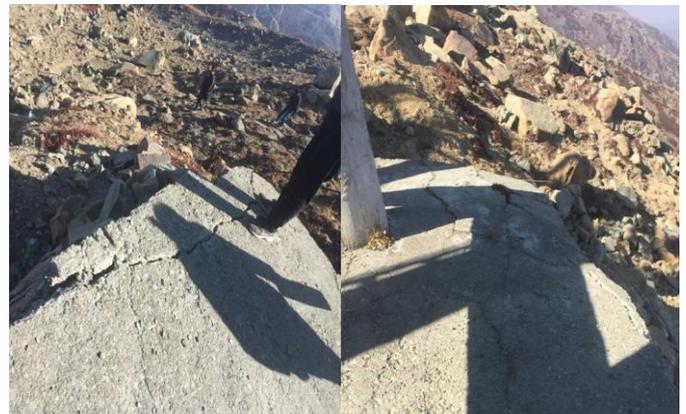
**Fig.4 Damaged Platform of T-15 (between Station-G4 and G3)**

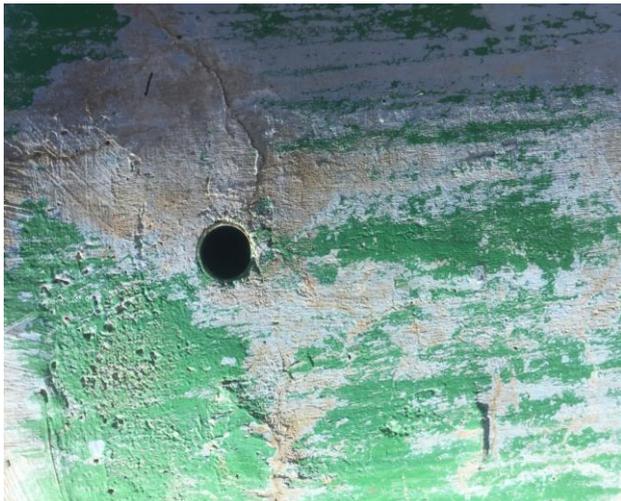
2. In Columns P4, P5 and P6 of Station G-1 due to wooden panelling access to the columns were not possible.
3. In columns of Station G-4, 1.6 inch diameter throughout holes were observed, these holes should be filled with suitable grout.

**Fig.2. Column of Station G-4, 1.6 inch diameter throughout hole**

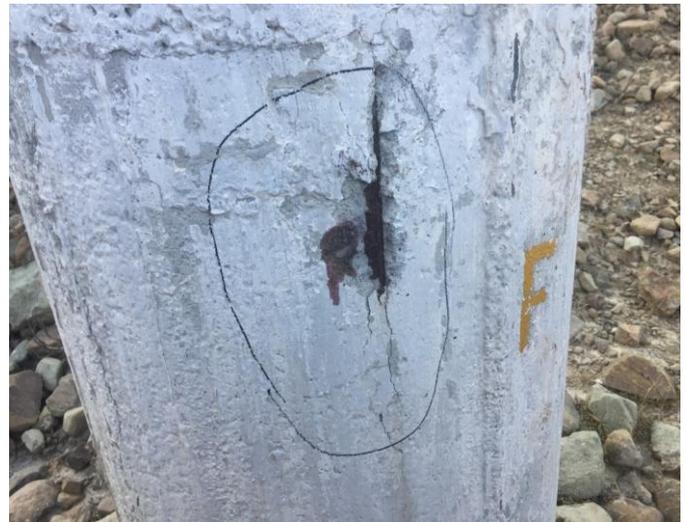
7. One downhill column of Tower T12 (between G-4 and G-3) was observed to be out of plumb.
8. In column of tower T7 downhill (between G-4 and G-3) hollow sound was observed on tamping with hammer. Also Downhill column had very less cover thickness; reinforcement bar is visible and has started corroding.

**Fig.5 Column of tower T7 had very less concrete cover, reinforcement bar is visible and rusting of reinforcement has been initiated**

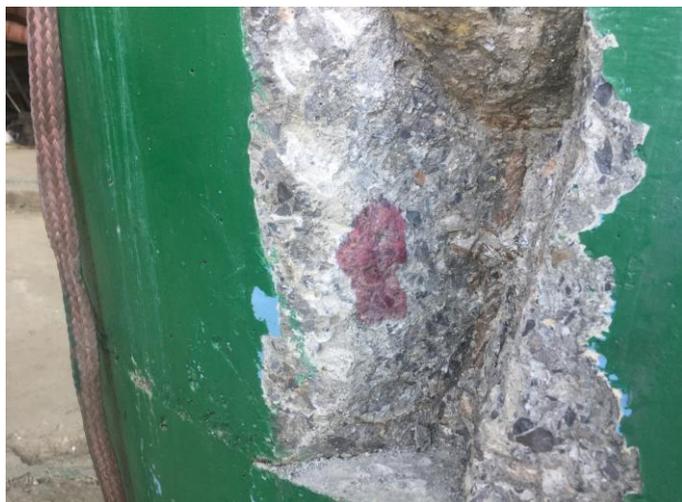
1. In column P2 of Station G-1 the cover of concrete is detached from the concrete and crack was also observed in same column. The hollow sound was also observed on tamping with hammer which indicates that the concrete cover is detached from the concrete column.

**Fig.6 In column P2 of Station G-1 the Column is damaged and on carbonation test showing red colour confirming the carbonation of concrete**

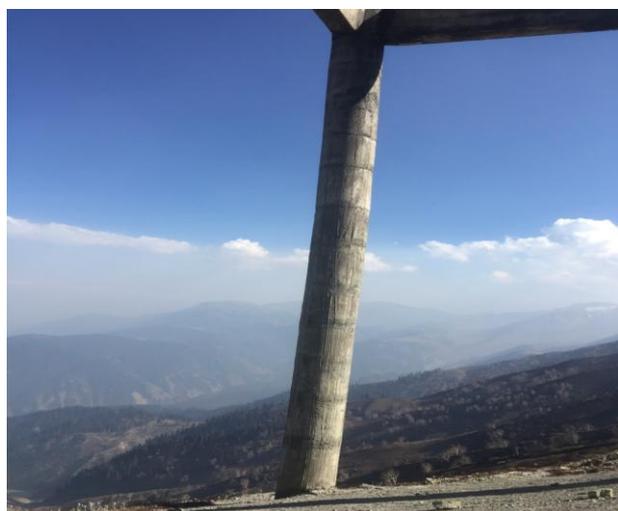
**Fig.7 Downhill column of Tower T12 (between G-4 and G-3) was observed to be out of plumb**

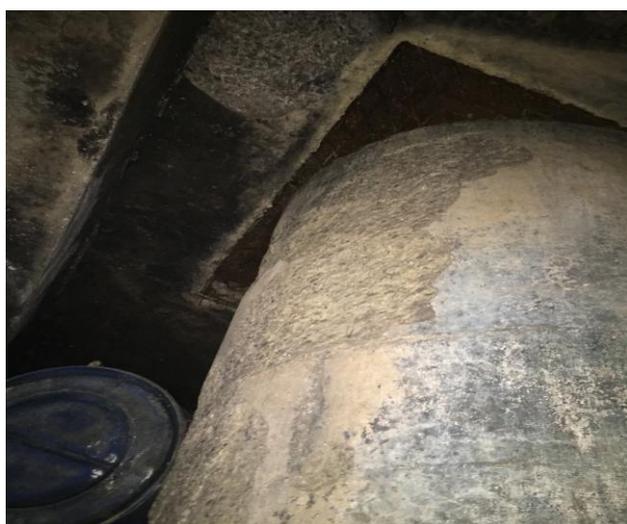
10. In column P3 of Station G-2 a wooden strip of 12"×2" was observed, which may be left there during the construction.
11. The outer surface of column P6 of station G-2 was observed to be abrading by the materials stored in the store room. No paint/protective coating was done on this.

**Fig.8 Outer surface of column P6 of station G-2 was observed to be abrade by the materials stored in the store room. No paint/protective coating was done on this**
