# Condition Assessment and Structural Audit Before and After Repair of Fire Damaged Structure and Ansys Simulation of Column Jacketing

Rajat R. Singh, P. B Kulkarni, A.K. Sharma

In this project, a residential and commercial building "Jagat Tower" in Nagpur caught fire. The reason of fire was short circuit in a cloth shop of basement and fire was for 7-8 hours. As a result of fire, severe damages in the structure were observed like spalling, cracking, and deformation etc of concrete members. This building is around 30 years old. Building has a basement plus six floors.

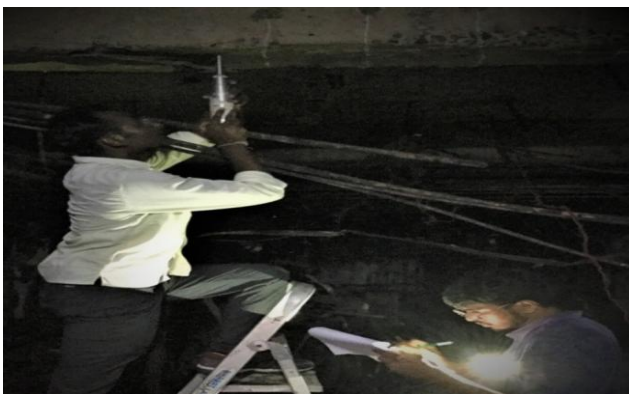
Fig. 2. Rebound hammer test

### IV. SCHMIDT/REBOUND HAMMER

Rebound Hammer Test was carried out on all the members after fire (before repair) and it found that compressive strength of the members varied between M15 to M20 in correlation with carbonation effect on rebound number. Hence, members with lesser compressive strength have been jacketed or repaired accordingly based on the severity and residual strength of members.

After repair again this test was carried out and it was found that compressive strength varied from 22 to 26. Hence, it was found that there is considerable increment in the compressive of members after jacketing and repair.

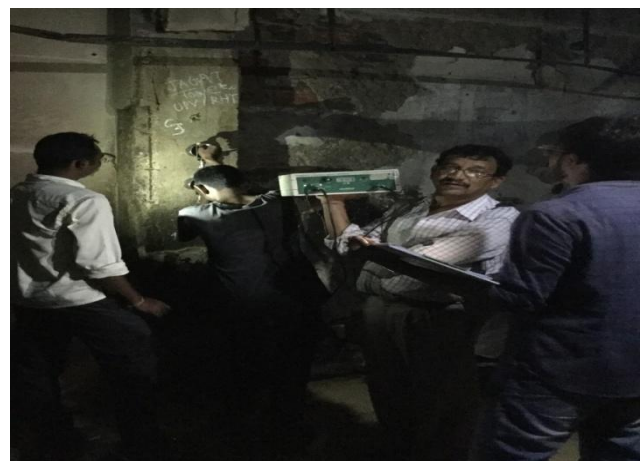
Fig. 3. Ultrasonic Pulse Velocity Test

It is done to evaluate the compressive strength and quality of concrete by ultrasonic pulse velocity method. This method consists of computing the time of travel of an ultrasonic pulse passing through the concrete being tested.

Relatively higher velocity is attained when concrete quality is good in terms of uniformity, density and homogeneity etc. A pulse of longitudinal vibrations is created by an electro-acoustical transducer, which is kept in contact with one the surface of the concrete under test. When the pulse generated is passed into the concrete from the transducer by means of a liquid coupling material for example grease or cellulose paste, it goes through multiple reflections at the boundaries of the different material phases inside the concrete. A complex structure of stress waves develops which consist of both longitudinal and shear waves, and transmit through the concrete. The first waves to arrive at the receiving transducer are the longitudinal waves, which are transformed into an electrical signal by a second transducer. Electronic timing circuits enable the transit time T of the pulse to be measured. Procedure is as per IS 133111992(Part I).

Ultrasonic Pulse Velocity test was carried out on all the members after fire (before repair) and found that values varied from 2.30 to 3.75. This indicates that concrete of most of the members is porous in character and has severe and significant cracks. Hence, members are in doubtful condition and need repair.

After repair it was found that values varied from 3.13 to 4.24. This indicates that cracks and voids in concrete have been minimized and repaired. The new jacketed column also has negligible voids.

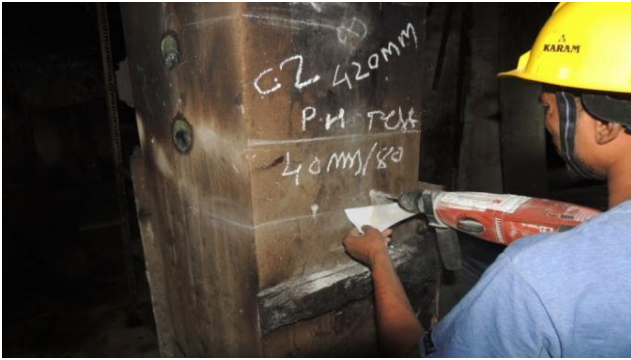
Fig. 4. pH and Carbonation Test

Although concrete normally begins its life at a very much basic pH of about 13, the pH values at exposed surfaces soon drop as reactions take place between carbon dioxide from the atmosphere and alkalis in the concrete. This process is known as carbonation. In due course of time, front of carbonated concrete, with lesser pH values, advance beneath exposed surfaces. It is necessary to find out the depth of this front, because carbonated concrete can lead to corrosion of reinforcing steel. Carbonation depth can be known by spraying a phenolphthalein indicator solution onto a fractured or cut surface of the concrete and noting the location of a color change. The depth of the carbonation front can also be estimated by using a drill to collect samples at selected depths. The Carbonation Depth test Procedure is followed as per BS 1881 (Part 201 ) 1986 clause 2.2

The Carbonation Test on all columns has been carried out. It was observed that because of poor quality of concrete resulted in rapid carbonation even beyond reinforcement.

The pH test of all columns has been carried out. Due to rapid carbonation during fire it is found that pH has also considerably dropped down.

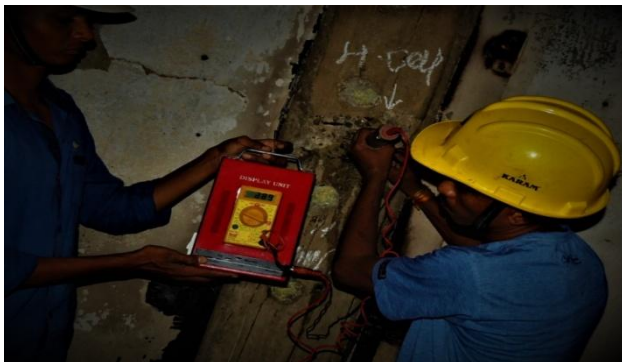
Fig. 5. Half Cell Potential Test

Corrosion is an electrochemical phenomenon. In this the electrode potential of steel bar with reference to a standard electrode undergoes changes depending on corrosion activity. The measurement is done by giving an electrical connection to the rebar and study the voltage difference between the bar and reference electrode in contact with the concrete surface. Generally, the voltage potential becomes more negative as the corrosion becomes more active. The general guidelines are according to ASTM C 876.

In this test after fire it was observed that the range of corrosion potential measured from -169 to -401 and lesser pH values concrete indicative of 80% probability that corrosion is active.

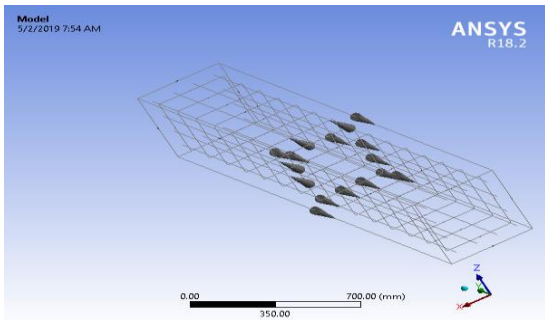
**Fig. 6. Geometry of damaged column**

The finite element software ANSYS is used to simulate the original column (400x400) and jacketed column (650x650) based on design process shown in fig 6 and fig 7 respectively.

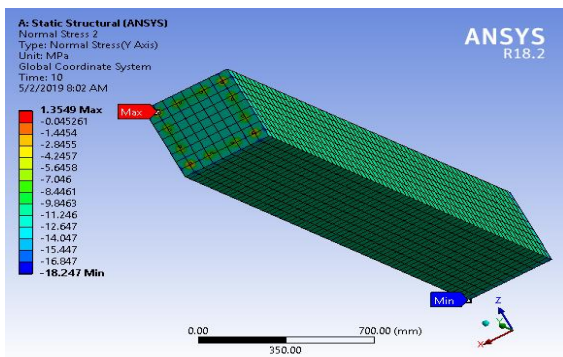
**Fig. 8. Stress variation in damaged column.**

It was observed that compressive stress developed in original column (400x400) is 9.146 Mpa which is greater than 6.9 Mpa (permissible stress of M15) concrete shown in table 6. With reference to Clause 38.1 C of IS 456:2000.

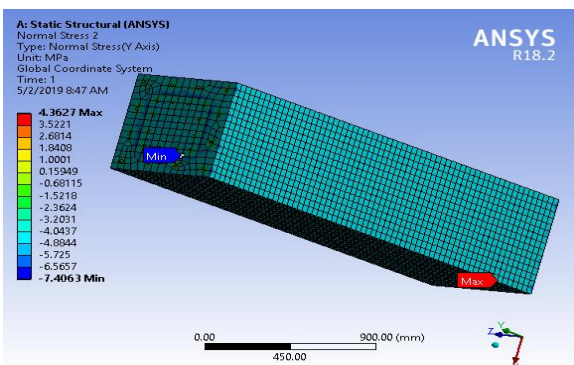
**Fig. 9. Stress variation in jacketed column**

In jacketed column (650x650) compressive stress developed is 4.0437 Mpa which is less than permissible stress of M15 and M25 concrete 6.9Mpa and 11.15Mpa respectively shown in table 7. With reference to Clause 38.1 C of IS 456:2000. Hence, design of jacketing is safe.
