Retrofitting Measures of Guntupalli Caves, West Godavari District, Andhra Pradesh, India, using Reinforced Rock Technique

Index Terms— Rock cut monument, retrofit technique, Reinforced rock, bending stress.

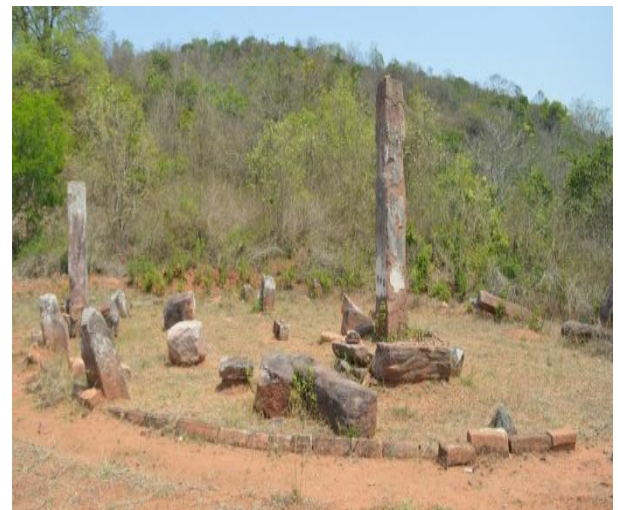
Fig. 5 View of ruined Mandapa

The type of structures / monuments in this site include mostly Rock-cut temples, monasteries, sacred stupas, ruined Mandapa etc., as depicted in Figs. 2 to 5

From test results it is shown that the strength of Mandapa Rock material (Sample – 3) is low compared to other two rocks of Caves and Votive Tombs. It is also observed that the Kondalite formation of Mandapa rock is highly affected by environment and weathering action.

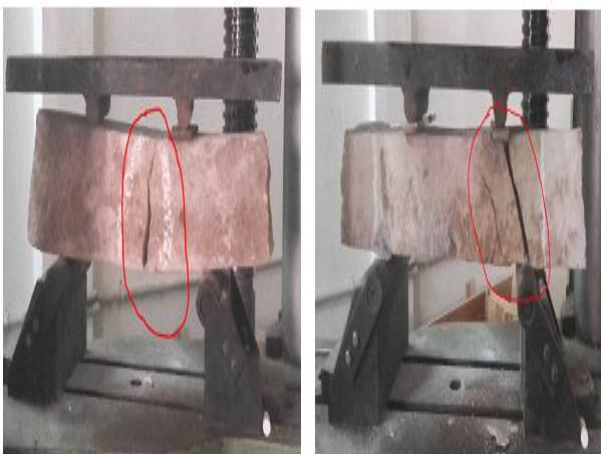
(a.) Without Reinforcement (b.) With Reinforcement
Fig. 6 Testing of Model Beam – A

Rock samples of beams were collected from two types of monuments; one from Monastery having characteristics of rock with mixture of sand stone and lime stone with smooth texture (Model –A) and the other from ruined Mandapa having characteristics of sand stone with porous texture (Model – B) and beam models of size 500 x 100 x 100 mm were prepared. One set of beam samples were then grooved to a depth of 60mm and width 40 mm on the assumed tension face. M.S flat of size 40 mm wide and 4 mm thick is then inserted into the groove and the remaining portion was filled with “Polyester resign grout”. Another set of same beam samples were prepared without providing groove or reinforcing flats.

These two sets of beam samples with and without reinforcement of beam Models A & B were tested for flexure

as shown in Figs. 6 & 7 and the results are presented in Table II

S.No	Type of Model	Flexural Strength (N/mm ²)	
		Without Reinforcement	With Reinforcement
1	Model – A	3.161	5.234
2	Model – B	3.140	12.000

From the test results, it is observed that for Beam Model – A, the flexure strength with reinforcement is increased by 1.65 times of the Beam Model – A without reinforcement; whereas for Beam Model – B, the flexural strength with reinforcement is increased by 4 times the Beam Model without reinforcement.

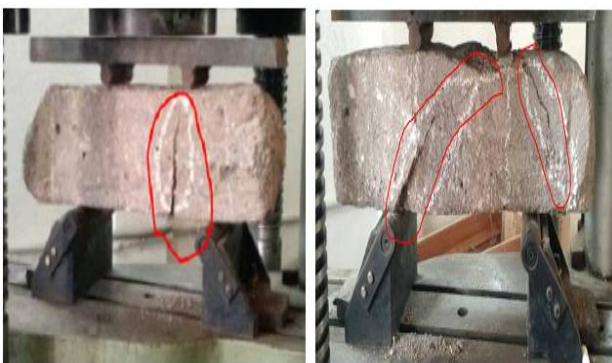
(a.) Without Reinforcement (b.) With Reinforcement
Fig. 7 Testing of Model Beam – B
