An Examination on Performance of Railway Sleepers

Suresh Kumar A, Muthukannan M

Keywords: Railway Sleepers, Failure of Sleepers, Alternative Materials, Minimise Failure

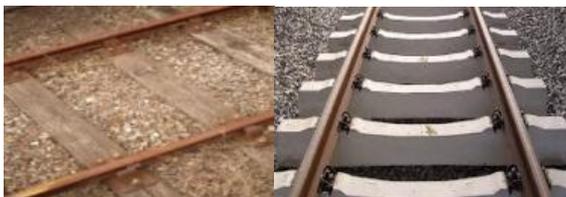
Fig. 1. Timber Sleepers Fig. 2. Concrete Sleepers

The most commonly used is Timber Sleepers (Fig. 1), these days the usage of pre-stressed concrete sleepers (Fig. 2) and steel sleepers (Fig. 3) are increased. The merits and demerits of materials used for the railway are mentioned inside the following Table 2 [1].

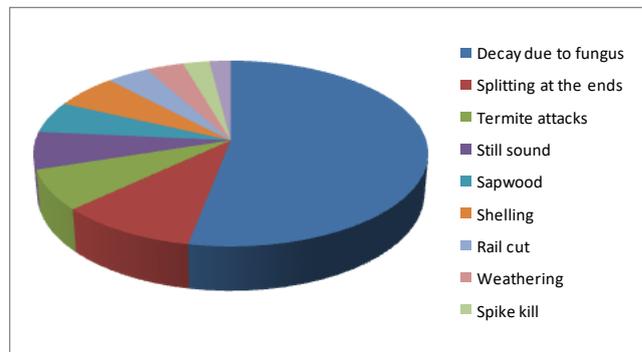
It is necessary to minimize the maintenance value of the track and to enhance the track performance by acceptable examination for the source of untimely failures of sleepers. The Railway of Australia (ROA) [6] surveyed several states in Australia to be able to understand the reasons and mode of timber sleeper failure. For this cause, in Queensland railway tracks nearly 2200 timber sleepers were tested and discovered various causes for harming the sleeper is inclusive of decomposing due to fungus, splitting at the ends, termite attacks, still sound, sapwood, shelling, rail cut, weathering, spike kill and knots (Fig. 4). In this, decompose due to fungus (53%), splitting at the ends (10%) and termite attacks (7%) have been determined to be the main reasons for the timber sleeper failure.

Fig. 4. Common causes of Failures in Timber Sleeper

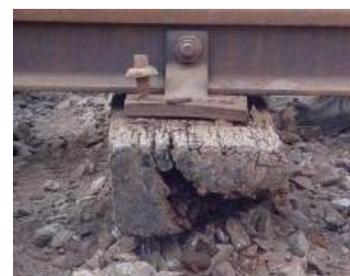
- *Decompose due to fungus:* Timber is a natural material, so it is prone to many plagues to biodeterioration. Decompose due to fungus is the primary mode of failure in timber sleeper. In timber, a fungus can be prone reposing till it gets appropriate surroundings carrying H₂O, O₂, and nutrients. Particularly in rainy seasons, railway sleepers can take in moisture, and it will make fungus active and if it present in timber, it can affect the integrity of track's structure by spreading from one sleeper to every other throughout nonnutritional surfaces [7,8]. The decompose due to the fungus of a timber sleeper (Fig. 5).

Fig. 5. Decompose due to fungus (9)

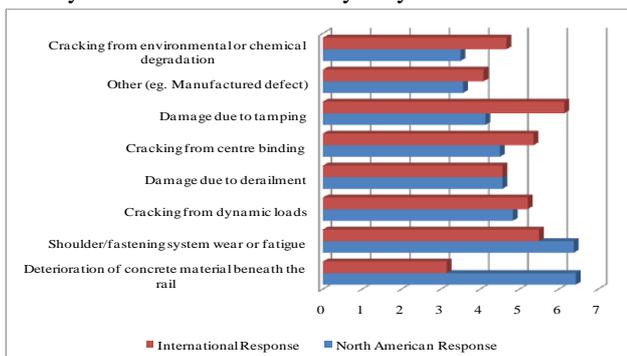
In the 1950's the sleepers are prepared by the concrete for many advantages. These days, in the international's railway networks approximately 500 million railway sleepers are made from pre-stressed concrete. Every 12 months, the request for pre-stressed concrete sleepers comprise extra than 50% of a general demand [3,4]. In 1970, Monoblock pre-stressed concrete sleepers are started using as a sleeper and in Australia, the large part of the latest railway sleepers are made of pre-stressed concrete sleepers [14]. The results from the North American and global surveys [15] are received and ranked the maximum usual reasons for failures in concrete sleeper (Fig. 8). The result specified that the crucial source of concrete sleeper failure is rail seat deterioration within North America and the installation or tamping harm globally. But, from country to country the mode of failures may vary.

Fig. 8. Concrete Sleeper Failures [15]

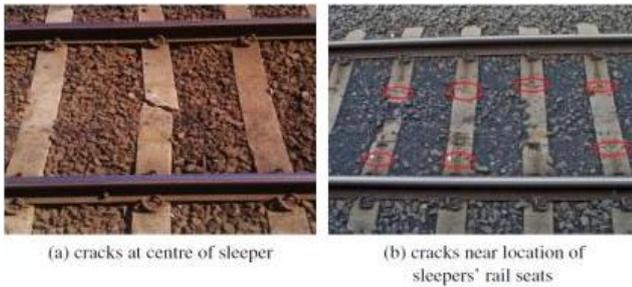
▪ **High-impact loading:**The flexural stiffness of the sleeper is reduced by the bending cracks at the midspan of concrete sleeper. During field inspection lots of cracks have been observed in concrete sleepers, the main cause identified is infrequent but in short duration high magnitude wheel load [24,25]. Present design recommendations are based totally on the most effective loading situations of static and quasi-static and do not recollect the excessive value of the impact load. (Fig 11) showing a crack due to impact loading on the sleepers. (Fig. 12a) illustrates the railway sleeper collapse and (Fig. 12b) the conditions of the joint in the repaired track. The investigational research conducted [26] and decided that the failure of sleeper under impact loading (Fig. 13a). A comparable non-performance sample changed into finding for the duration of an area investigated which verified

Fig.11. Cracks due to impact loading in concrete sleepers [27,28]

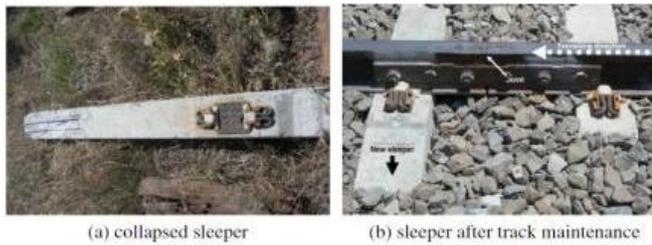
Fig.12. Impact damage due to rail irregularities to sleeper [30]

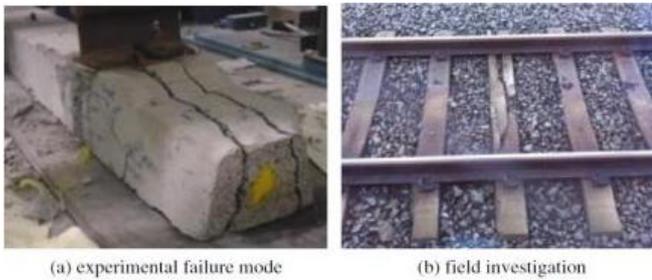
failure of sleeper under impact loading (Fig. 13b).

Fig. 13. Splitting failure caused by impact loading in concrete sleeper [26]

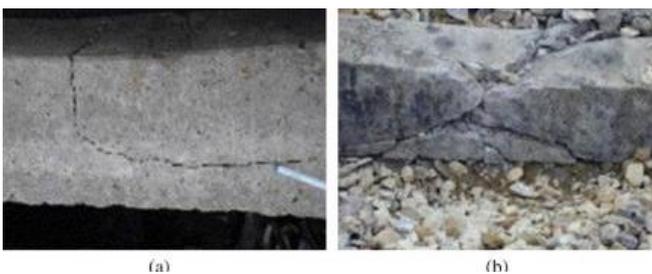
▪ *Center-bound damage:* In a mainline railway track, the tensile fracture may occur on the pre-stressed concrete sleeper. They observed a tensile fracture on the top of the sleeper (Fig. 14a) which spread the cracks after the expecting duration of its crucial phase and “X” shape fracturing is formed clearly (Fig. 14b). A new study [30] located that a sleeper installed in the railway track before the service has failed by longitudinal cracking (Fig. 15a). During service, a further outcome like freezing of water and fine rocks existing in rawlplugs will cause longitudinal cracks (Fig. 15b). The same conclusions have been given [31] who determined that the principle purpose of longitudinal cracks in a sleeper is due to the excessive shearing tensile stress at bolt hole edge.

Fig. 14. Tensile fracture in concrete sleeper [32]

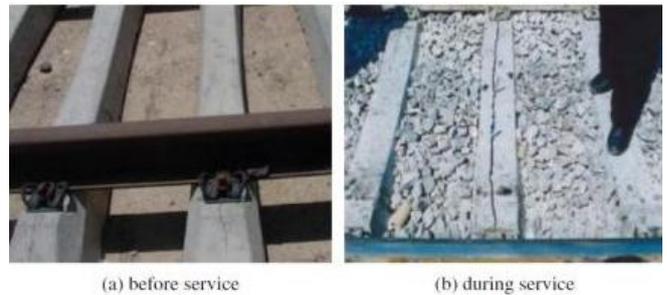
Fig. 15. Longitudinal cracking between rawlplugs [30].

- *Control of longitudinal crack:* The main reason for longitudinal cracks is due to the excessive shearing tensile stress around the bolt hole/ rawlplug. To minimize the shearing tensile stress [31] by using a special concrete within the inner part and normal concrete at the outer part of the bolt-hole region. The alternative method to reduce longitudinal crack is by changing the direction of crack and cracking planes by placing a transverse reinforced bar to strengthen the sleeper transversely and to induce pressure around the rawlplug hole [30].

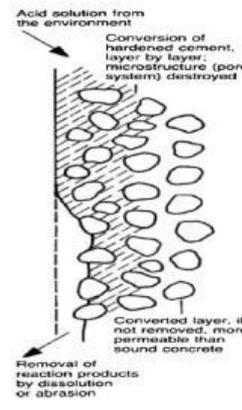
▪ *Acid Attack:* The strong acids will easily attack the concretes that are made from OPC [33] and when hydrates in cement come into contact with the acids then $CA(OH)_2$ will convert into salts with more calcium [34,35]. Also, acids can attack calcium aluminate hydrate and calcium silicate hydrate (C-S-H) [33,35] and the effect of acid attack (Fig. 16). The main source of acid rain is the emission of the huge amount of SO_2 and nitrogen oxide into the environment.

Fig. 16. Effect of acid attack [35].

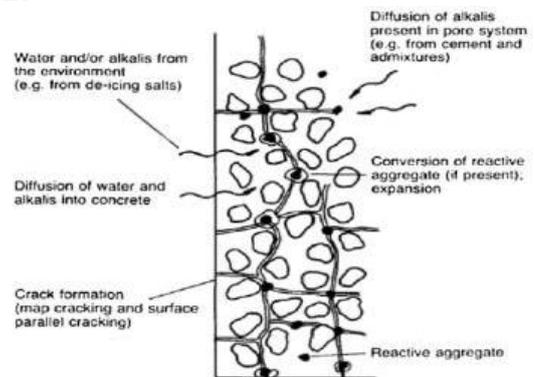
▪ *Alkali-Aggregate Reaction (AAR):* The reactive substance in the cement and in the aggregates is the main difference between sulphate and alkali attacks [35]. Despite the fact is that Ordinary Portland Cement (OPC) is the main supply of alkalis in concrete, on occasion, a further one is an unwashed fine aggregate containing sodium chloride and combining water is also taken into consideration inner resources [33]. (Fig. 17) Effects of AAR

Fig. 17. Effect of AAR [35]

The AAR is liable for sleeper failures due to the reasons of parallel longitudinal cracking at the top surfaces and maps cracking at the ends of pre-stressed concrete sleepers [36]. This was

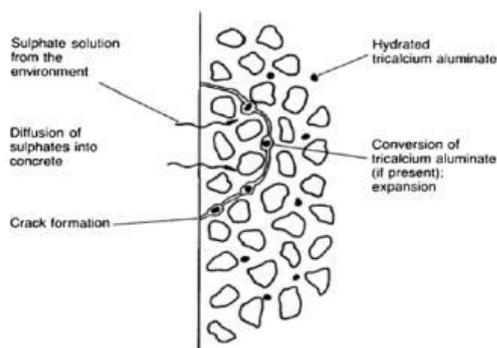
▪ (DEF) – *Delayed Ettringite Formation*: The deterioration of concrete is occurred by cracking. If the aggregate, soil, and groundwater contain sulfates of magnesium, calcium, sodium, and potassium. In solution, if sulfates are presented, then it will react with the calcium hydroxide and tricalcium aluminate. This reaction causes expansion and it leads to cracking [33,34] as depicted in (Fig. 19).

Fig. 19. Effect of sulphate attack [35].

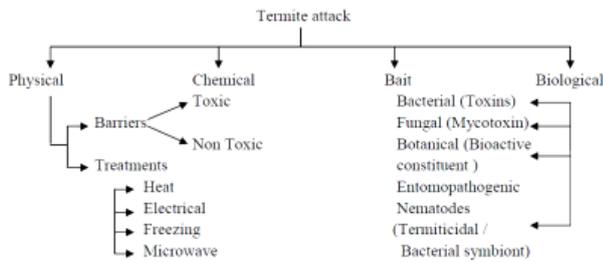
▪ *Decompose due to fungus and attack due to termites*: The safety procedures in timber structure are quite similar for controlling fungus and termite attack [45], and recent time, the most common technique used is soaked with synthetic chemicals and biological prevention have been studied by many researchers. The harmful organisms in timber can be destroyed by some toxic chemicals. These chemicals were used for more than 200 years because the cost is very low. The application of chemical preservatives and disposal of the timber sleeper have become a big concern for environmental agencies [46]. Lately, it had been emphasizing the usage of chemicals used to protect the timber by biological protection techniques that deal with public worries and it conforms with new environmental policies [45,47]. The loss of dignity of timber can be controlled by biological as actual as chemical prevention and environmental safety is one of the additional benefits. (Fig. 22) diagrammatic illustration of

measures to control termite in timber structures.

Fig. 22.Measures to control termites

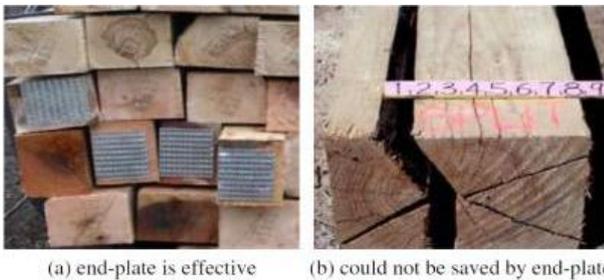
- *Control of end splitting:* The timber splitting at the ends can be controlled by fixing a plate at its end [8,48]. This method is applicable when the width is less than 20mm and length not more than 250mm. The limits accepted for splitting for seasoned and unseasoned sleepers are width 6mm and 3mm for 100mm long. Consequently, the sleepers beyond the accepted limit but width not more than 20mm and length 250mm, by using end plates it can be saved. (Fig. 23a) saveable and (Fig. 23b) non-saveable timber sleeper.

Fig. 23. End-splitting failure minimization technique [8]

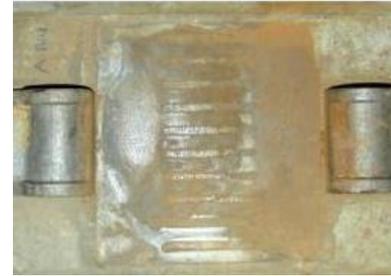
- *Preventing abrasion in rail seat:* In North America, the most critical problem for concrete sleeper is due to rail seat deterioration. Numerous researches have concentrated on minimizing and arresting these failures. In 2003 [49], attempted by using the plates made of steel to cover the area of rail seat to minimize abrasion. There is no rail seat abrasion occurred when the experimental program of fatigue testing completed, which ran 10 million cycles at a rate of 2.5 cycles/sec (Fig. 24). However, the cost of the manufacturing sleeper is increased for additional steel plates and the water presented below the concrete will lead to deterioration in the rail seat region. While adopting this approach, the above issue should be carefully considered. Coating with Epoxy over the area of rail seat is another approach to prevent abrasion [50]. However, wearing of epoxy, epoxy curing required more labour and during the application, the track should be closed because of these reasons this method is not a convincing one. The researchers have considered some different preventive methods are: in the rail seat area the concrete with silica fume and fly ash [51]. During manufacturing, steel fiber reinforced grout introduced in the area of rail seat

[49,52]. In rail seat area placing of metallic aggregates [53]. In 2002 [54], Abrasion-resistance properties are more in High volume fly ash concrete and the areas where highly abrasion-resistant is required High volume fly ash concrete is suggested. However, the compressive and tensile strength of the concrete in the rail seat area can be increased by adding some materials to concrete [19,51].

Fig. 24.Rail seat covered by a steel plate after 10 million cycles [49].
