Preserving the Architectural Heritage within an Academic Framework

Mahmoud Tarek.M.Hammad

III. PRESERVATION PROPOSAL AT AL-DHAFEER VILLAGE

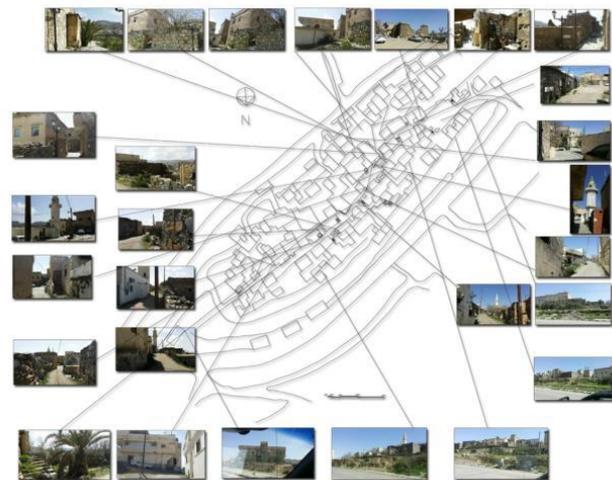
Figure 3: Organization diagram of buildings located longitudinally at the main path of the village

The Urban planning of the old village is characterized by simplicity and uniformity and reflects the design style of buildings. The pattern of the urban planning reflected the security aspects at that time where buildings were built in a compact form without large spaces between them, and generally on a hilly terrain. (Figure:3)

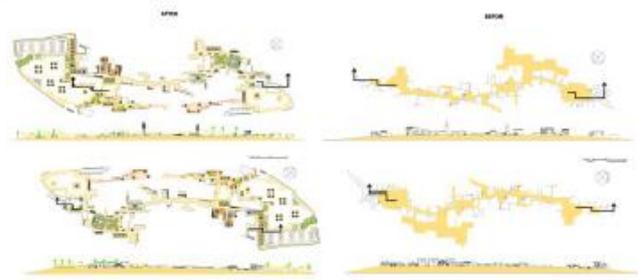
Figure 6: The proposed strategy after and before rehabilitating operations
Source: researcher

The longitudinal path which runs through the middle of the village of Al-Zafeer and extends longitudinally from northeast to the southwest has been identified to be the scope of the current study and as a main foundation of the current project. This path has a set of mainly and secondary spaces where collections of heritage buildings are overlooking (figure:6).

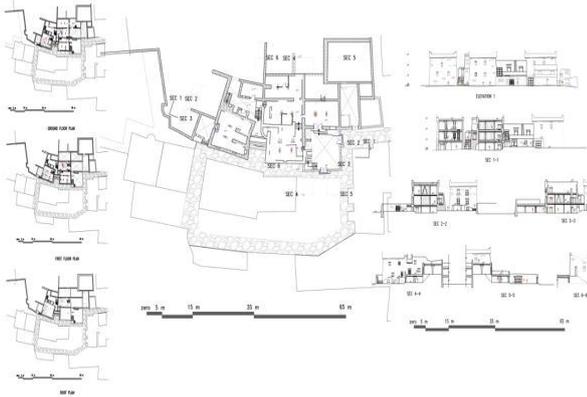
figure 7: The current plan of the Emarah
Source: researcher

Al-Emarah compound was documented in the current situation (drawing of plans, facades, and sections) as shown in (Figures:7),and Several photographs from different angles were taken as shown in (Figures: 8&9).

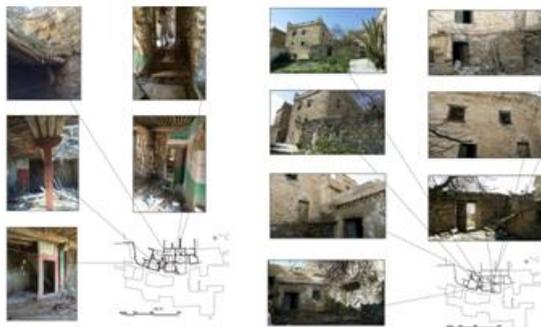
Figure 8: shows the Photographic documentation of the Emarah from abroad
Source: researcher

Figure 9: shows the Photographic documentation of the Emarah from inside
Source: researcher

The buildings are not currently occupied or used, but neglected completely. Parts of the buildings and their accessories are collapsed. The roofs are those parts heavily ruined due to the effect of rains in a condition of abandonment and neglect.

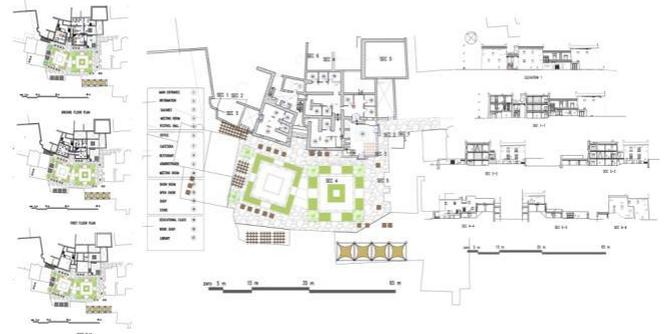
figure 10: re-employment proposal plan of the Emarah
Source: researcher

The current project proposes a re-use of the El-Emarah building after the renovation to become a museum of the region heritage. The principal condition of this proposal is not to abuse interior spaces and their functional relationship. The changed functions of the restored buildings should comply with the current design. The museum will include halls of artifacts and small cafeteria for visitors, an educational library, some crafts workshops and educational classes all recommended is shown in (Figures 10). A compilation of perspective perception before and after the rehabilitation proposal is shown in (Figure 11).

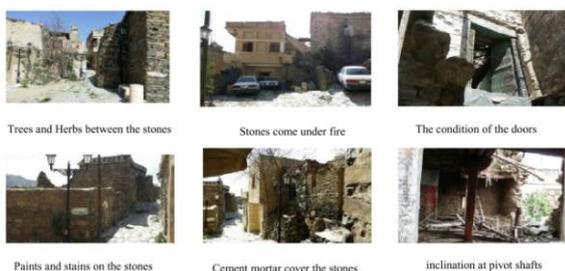
figure 12: the problems that have been detected in the stones of the village

The stones in the village of Al-Zafeer heritage village are of local origin. They are mainly of igneous and metamorphic origin. These types of stones are irregularly shaped and used in general for **external** interfaces. In restoration works, these stones must be given priority and could be reused from other ruins. Reformation of stone elements, architectural blocks and columns should follow previous forms. Proposed new materials must be largely homogeneous with the existing elements in terms of, mechanical resistances, mineral composition, and colors...etc. Documented problems were noticed between the stones used in the construction of the village such as trees and herbs. Stones also accidentally came under fire, covered with cement mortar, paints and stains as shown in (Figure 12). Techniques used to treat the outlined problems could be implemented;

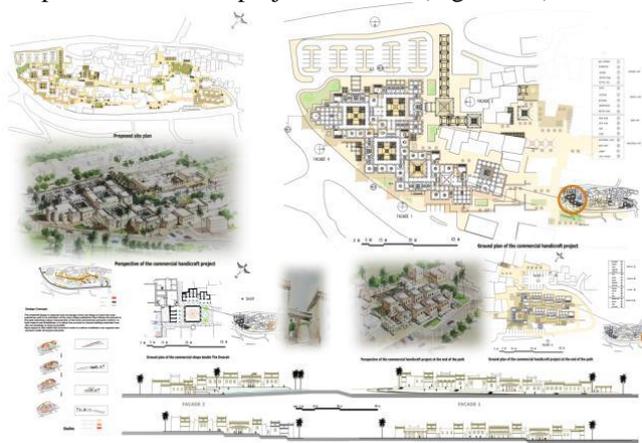
Figure 13: The drawings of The proposed commercial handicraft project

Along the principal axis of the main path in the village, a center of commercial handicrafts in the northern part at the beginning of the path is to be established. The second stage will include a compound of commercial activities in the middle part of the path. At the end of the principle part, a center of services including paramedic, security, rescue communications and customer services is proposed. Principles and criteria for new buildings in the surrounding region should be in harmony with those followed in the heritage buildings. It is proposed to maintain a height criteria in transition zones (Buffer Zone) with the old ones. The height of new buildings should rise gradually to afford a skyline view to the heritage areas.

The proposed design is inspired by the design of the old village in which the main pedestrian path is an extension of the main village one, thus linking the present to the past imparting unique characteristics of the local environment and gives comfort to both visitors and inhabitants. It was taken into account to choose building materials from the surroundings as much as possible. Open spaces are also taken into account in order to achieve ventilation and regulating the temperature of all the project elements (Figures 13).
