Al-Hadba Minaret in the Last 100 Years

Rasheed Saleem Abed

Keywords: AlHadba minaret, Mosul heritage, leaning, deformation surveying.

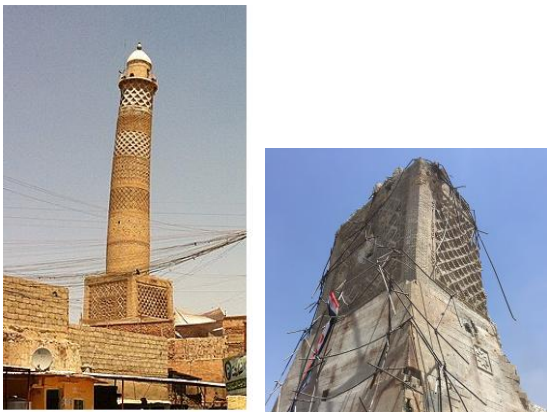
Fig. 1. Al-Hadba as before and after 2017.[1].

The Al-Hadba minaret in Mosul is believed as one of the most important historical and Islamic monuments in Iraq built by Nouredin Zanki around 1172 AD [1]. It is located in the old Mosul on the right side of the Tigris River fig. 1. The minaret remained steadfast all these years until the summer of 2017, when it was destroyed by fighting that also destroyed part of Mosul's oldest heritage area nearby the minaret.

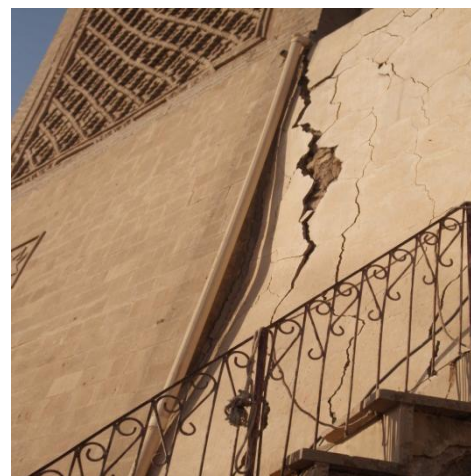
Fig. 2. Cracks appearing near the base of the minaret.
