# Low Velocity Impact Damage Analysis in Plain Weave Woven GFRP Laminates Through Optical and SEM Microscopy

M. A. Kounain, Z. Khan, F. Al-Sulaiman, N. Merah

**Abstract:** In the present study, instrumented drop weight impact tests at different impact energies were performed to investigate the modes and mechanisms of the low velocity impact damage in plain weave woven glass fiber reinforced plastic (GFRP) composite laminates. 8-ply, 16-ply, 24-ply and 32-ply laminates having identical  $0^\circ$  layup were examined via optical and scanning electron microscopy after free falling weight single bounce impacts. It was found that under low velocity impact the failure was initiated by matrix cracking at the interstitial region of  $0^\circ$  GFRP composite laminates. These matrix cracks were much extensive in 8-ply laminates as compared to laminates with larger number of plies. These matrix cracks propagate to cause fiber fracture and fiber matrix debonding and extend across the thickness of the laminate to introduce delamination. The eventual failure thus occurs through the combination of matrix cracking, fiber fracture, fiber matrix debonding and delamination.

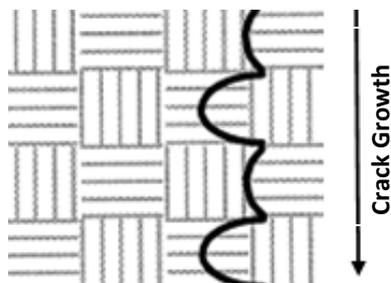
Figure 10. Delamination crack propagation in a woven-composite laminate [Error! Reference source not found.].

The progress of *crack* propagation at the bottom face of the specimen can be observed in Figure8 (a), which is schematically illustrated in Figure. Crack propagation in woven fabric composites considering its geometry is known to be rather complex when compared to that of non-woven unidirectional composites [Error! Reference source not found.]. In woven composites crack propagates parallel and as well as perpendicular to the fiber direction. The crack

advances along the direction of fibers and as the crack propagation becomes rather unstable at a sudden load drop the whole crack front jumps forward across the perpendicular strand of fibers which is then immediately arrested at the next ripple forming a continuous crack front (see Figure). This is repeated until complete delamination of the laminate takes place.

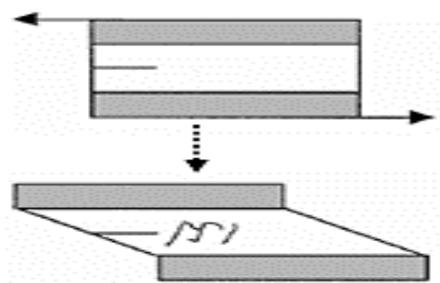
SEM micrographs in Figure (c), Figure 9 (b) and Figure (a, b) shows the formation of *hackles* at the fiber-matrix interface. During mode II shear deformation, as shown in Figure 11 each end under shear stress deforms in opposite direction, which leads stress to concentrate at the fiber-matrix interface, and as this stress increases a micro-crack is formed at the crack front in case if the interface is strong

enough to endure the applied shear stress, and when the maximum effective stress at crack tip reaches the critical value, the micro-crack coalesce to form macro-crack and the macroscopic crack advances leading to *shear band* commonly known as *hackles* [13] as observed in this study. The formation of *hackles* increases with the increment of impact energy as observed from these SEM micrographs.

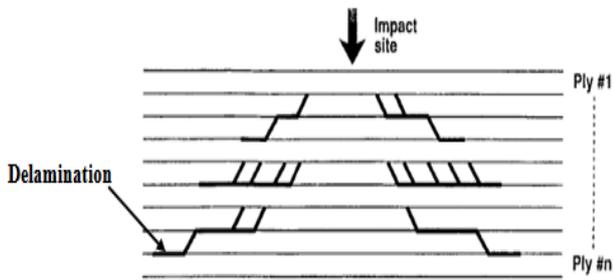
**Figure 14. Schematic of cone of damage due to impact [13]**

formation of a cone-shape delamination zone (contrasted as white color) with increasingly extensive damage towards the bottom face as seen in Figure. The cone-shape delamination zone has been observed in various studies on non-woven composite laminates, but a similar phenomenon was also observed for woven-fabric composites. The cone or also known as the *pine tree* damage pattern comprised of delamination and had its apex at the top (near the point of impact) as shown in Figure (a) and a widening base through the thickness of the laminate as also shown schematically in Figure 14.
