Retrofitting and Rehabilitation of damage footbridge over Yamuna River

Anjani Kumar Shukla, P R Maiti

Abstract: Every Structure has a certain predefined age with which it has to withstand, and after that, it requires the rehabilitation/repairing to avoid any damage or collapse. The footbridge over Yamuna River in Delhi, India was constructed in 1960 adjacent to Wazirabad barrage, and this is a very important link to East Delhi and West Delhi. Due to heavy traffic plying on this footbridge, in due course of time, the signs of deterioration were visible in the bridge expansion joint assemblies in the deck slab and cantilever portion of footpath slab. There were many potholes also developed in the wearing course. It was also dilapidation observed in many portions of the footpath, and some portion of the footpath slab were collapsed. The cantilever portion of the footbridge was retrofitted with steel jacketing fixing in the main longitudinal girder of the bridge. In this study analysis of the cantilever footbridge slab retrofitted by a steel jacket was carried out to check the deflection and stress limit of the bridge and it is found that the bridge is safe and now Bridge is open for

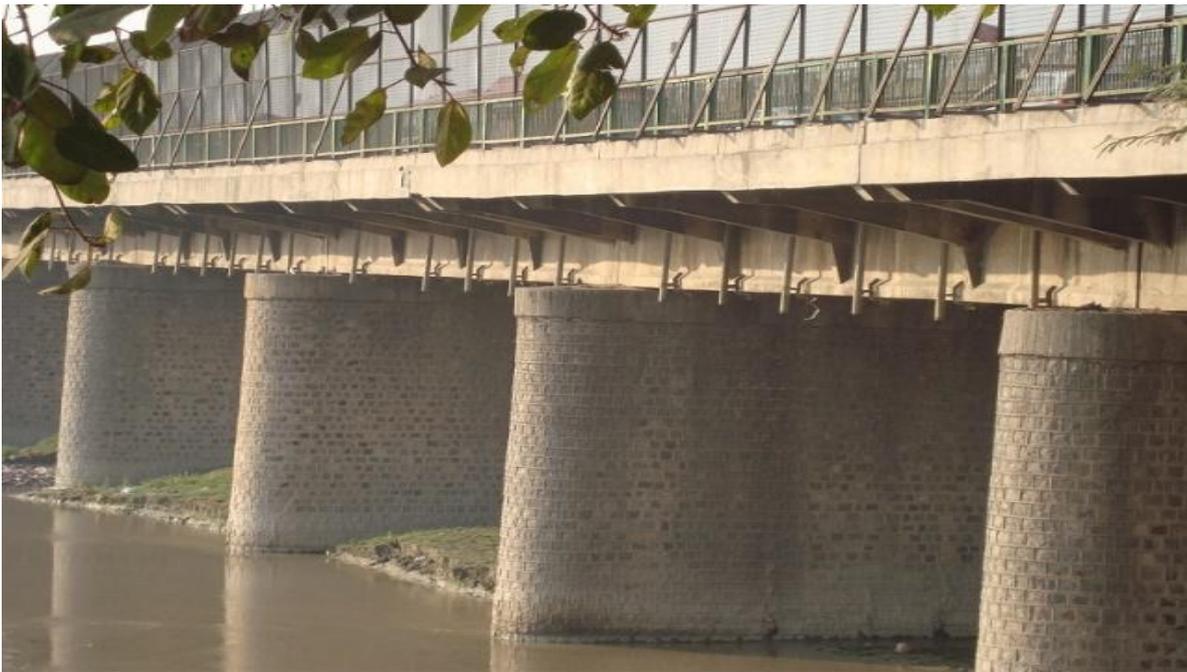
Figure 2 Global Image of Yamuna Bridge

The 23 span Bridge consisting 22 concrete piers and 2 abutments. The total length of bridge is 460 meters and total width of footbridge is 3.0 meter. It is supported on cantilever is situ cast beam. Figure 2 Present a global view of footbridge portion supported on cantilever beam. The Bridge has 2.5% Longitudinal and 0.75% of traverse slope.

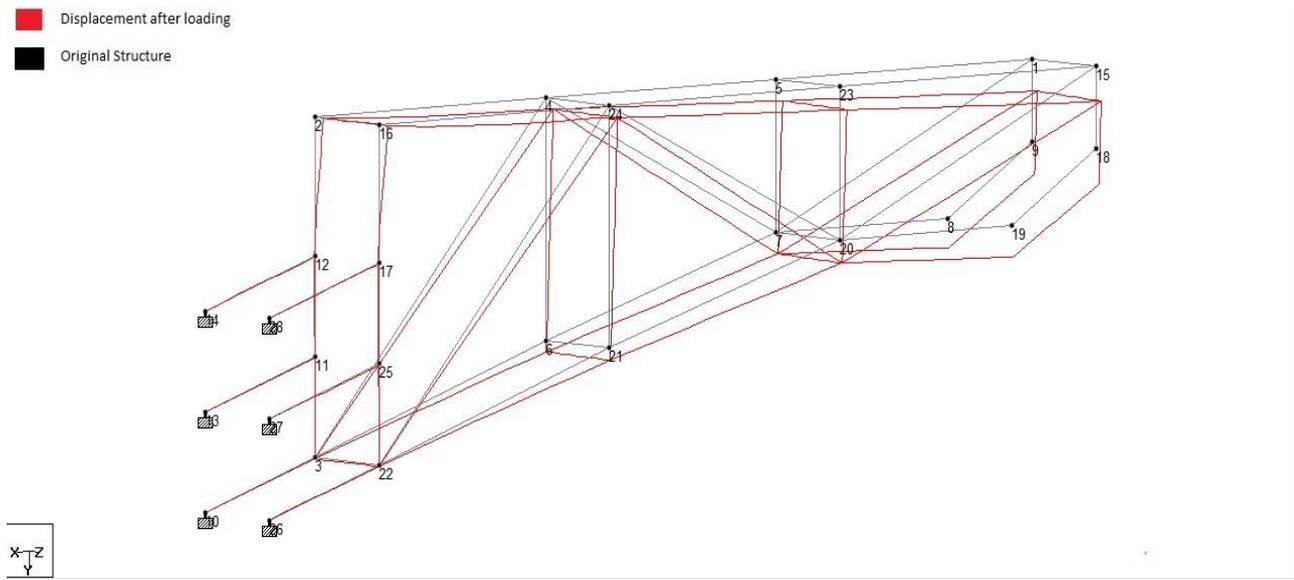
Figure 13 Deformed shape of Steel Jacketing Structures

The analysis of jacked steel structure using STAAD.Pro V8i was carried out to check whether structure is safe or not. In Figure 13 the deflected shape of steel jacking structure and Node displacement in Figure 13 is shown when it is loaded.

1. The Maximum Resultant Displacement is 9.526 mm, which is in downward side.
2. The Maximum Horizontal Displacement in X direction is 4.957 mm.
3. The Maximum Axial Compressive Stress is -9.227 N/mm² in both steel beam which is fix with main girder of bridge and between node 22-26 and 3-10.
4. The Maximum Axial Tensile Stress is 21.824 N/mm² in Both steel beam which is fix with main girder of bridge and between Node 17-28 and 12-14.
5. Retrofitted footbridge were open for the traffic (Figure 14) when analysis steel jacketing members and found all safe.
