Compressive Strength of Masonry Units in Cagayan's Heritage Churches: A Reference for Sustainable Preservation and Seismic Vulnerability Assessment

Abstract: This study addressed a critical data gap concerning the mechanical properties of Unreinforced Masonry (URM) materials used in Cagayan's Spanish colonial-era heritage churches, which are significant cultural assets highly susceptible to seismic activity. The Philippines is an earthquake-prone country, ranked second globally for exposure to natural hazards. While historical accounts confirm that Cagayan's churches were extensively constructed with brick, a previous comprehensive national assessment of indigenous URM properties unintentionally missed collecting samples from this critical region, highlighting a continuing need for specific local scientific studies. Understanding the fundamental strength parameters of individual masonry units is crucial for accurate seismic vulnerability assessments, an indispensable first step in mitigation efforts for cultural heritage preservation. Therefore, this research aimed to comprehensively characterize the compressive strength of these masonry units to provide an essential reference for

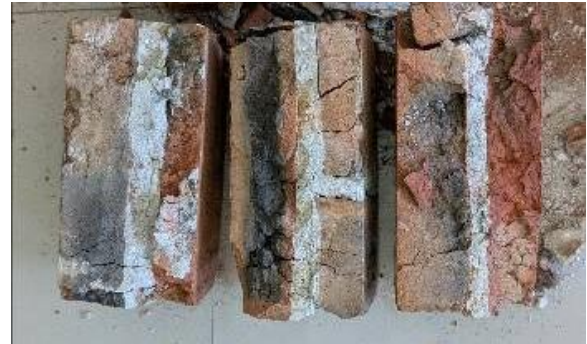
[Fig.1: URM Block Specimens]
