Through Hole Component Inspection Monitoring System

Abstract: For PCBA with through hole components, there is no easy, automated way of inspection like using AOI and AXI as employed for the Surface Mount Technology (SMT) components. As there is no such specific efficient inspection tool, till date manual inspection is the only solution for identifying defects in the Through Hole technology. Thus proposed work is defined to inspect few of the through hole component defects in an automated approach. Even though AXI is capable of detecting the Through Hole defects, it is rarely implemented due to its inaccurate results and cost. This results in increased cycle time, moderate efficiency, expensive and is very difficult to be focused for the operator on such repetitive task and that in turn affects the productivity and yield. As not much of research work has been carried out to find solution, a simple image processing technique has been tried here. In the proposed system a pattern matching technique is used for inspecting the defects like presence and absence of the Through Hole components in assembled PCB. In this work few different PCB images of same product have taken for inspection

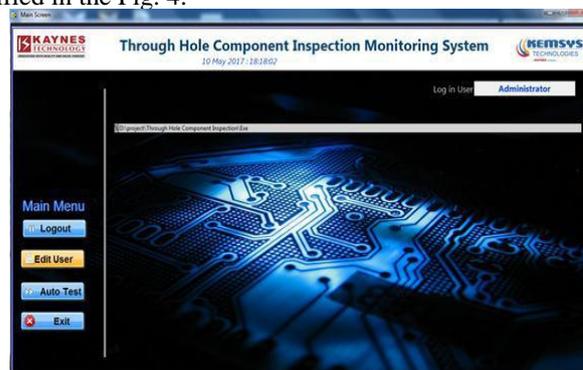
Fig. 4. Admin Enabled Window

The front panel window is designed in terms of user friendly controls, which enables a user or a guest to make the best use of this system with simplicity and efficiency. The whole system is designed effectively with authentication details and passwords which support implementing a secured and efficient system for monitoring the Through Hole component missing defects. The upper portion of the display specifies the name of the project, the company logos and the current date and time display which is linked with the system date and time display. The left most part describes the Main Menu field, which contains the various fields defined with respect to the program. The next part left in the window is the white row that specifies the path of the stored program. Initially as we run the program, the result window displays along with the enabled Exit and Login options, that is specified in the Fig. 4.

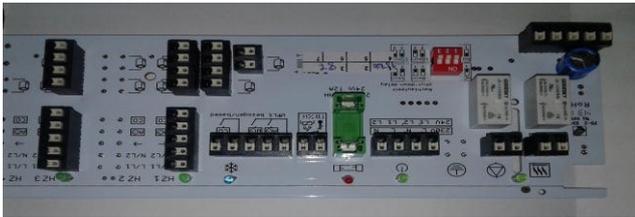
Fig. 5. Reference good Image

After Training entering details of PCBA, import a PCBA image and select a component the selected region will be highlighted in green colour. The good and bad board image considered for operations is shown in Fig. 5. and Fig. 6. respectively. Further select —Configure button, then select the —Analyse button to find out the pattern. The Figure 8 specifies the configuration of selected component. The resultant window specifying 1st pass board is shown in Fig. 7.

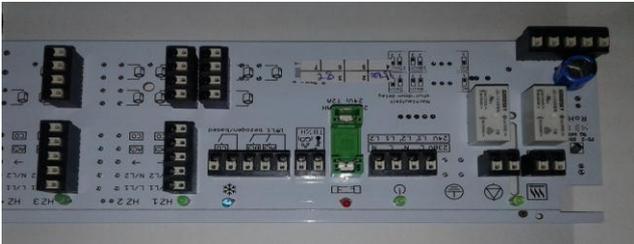
Fig. 6. Reference Bad Image

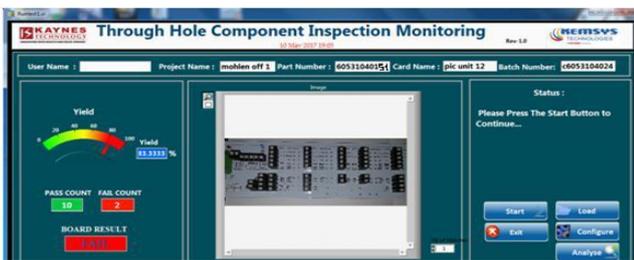
Fig. 7. Final Resultant window
