Investigation for Finding out Difficulties in Construction of High Rise Building & Suggest Remedial Measures to Expedite the Execution Process of Activities

Dhammakar Dhammanand Chandrakant, Arjun. R. Vasatkar

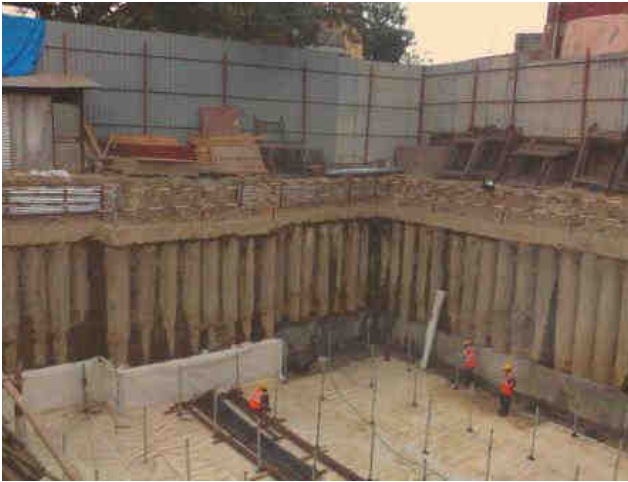
Figure1. Plume concrete wall constructed for fixing waterproofing membrane at Project site

Two rounded shore piles constructed adjacent to each other in straight line does not form line & level surface because of rounded shape. To make it in line & level surface by providing shuttering at edge of shore piles, Space between two adjacent piles is needs to fill with lean concrete. This activity is known as “Plume concrete wall”. Plume concrete wall is not a structural member. It is constructed just to provide line & level surface for fixing waterproofing membrane on it, So that water could not entered from soil through retaining wall & later in basement area.

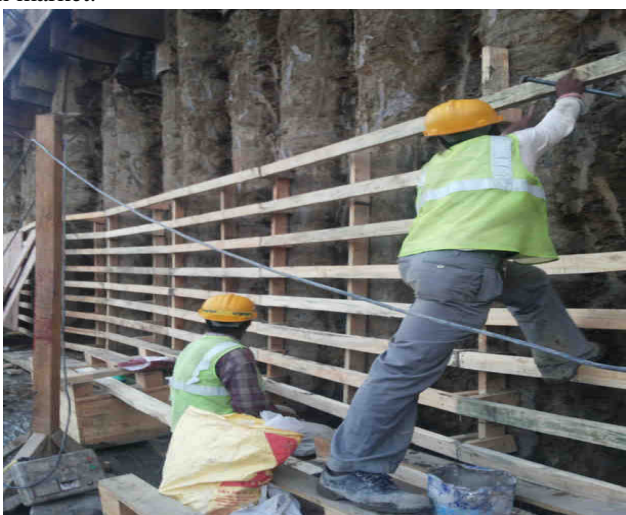
Figure.2 Wooden framing for skin wall construction

- Setting out of layout
- Fixing vertical wooden runner (Section -4" x 3") with shore pile with MS flat by screwing.
- Fixing Horizontal wooden runner (Section -3" x 2") with vertical wooden runners by screwing.
- After wooden framing completion 12mm commercial plywood is fixed on it for line & level surface.
- Once commercial plywood gets fixed, it is ready for fixing waterproofing on it.

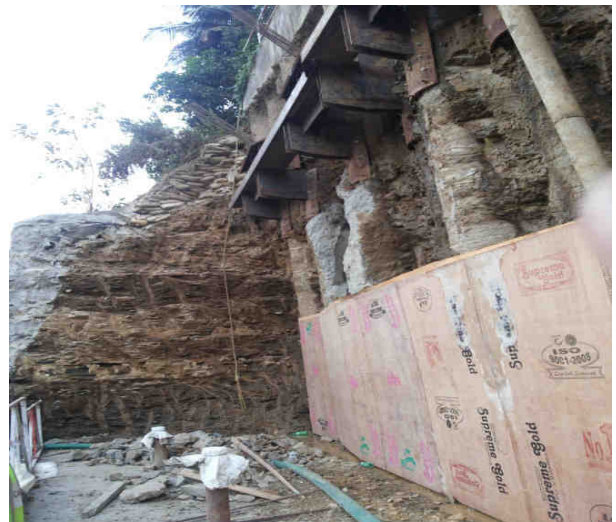
Figure.3 Commercial plywood fixed on wooden frame constructed for skin wall

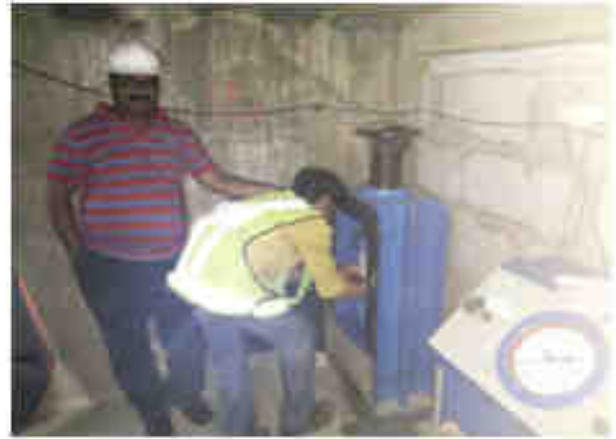
Figure.4 Cube testing of plume concrete wall (M5) for compressive test

Days	Compressive Test (N/mm2)			Avg Load (KN)	Weight (Kgs)			Avg Weight
	Load-1 (KN)	Load-2 (KN)	Load-3 (KN)		W1	W2	W3	
7Days	130	150	160	146.67	8.51	8.54	8.61	8.56
8Days	200	210	220	210	8.54	8.62	8.72	8.63

- Avg 7 Days Strength :-146.67 KN = 146670 N
Compressive Strength: -Load/ Area of Cube
146670/22500
6.51N/mm²
- Avg 28 Days Strength:-210 KN = 210000 N
Compressive Strength: - Load/ Area of Cube
210000/22500
9.33N/mm²

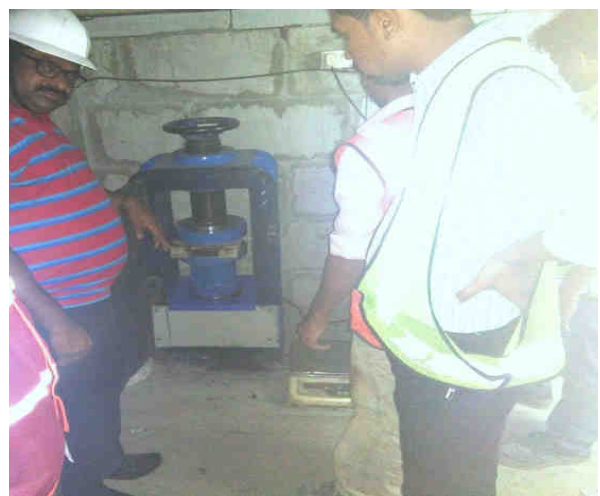
Figure.5 Compressive test carried out on Skin wall Sample.

Compressive Test (N/mm ²)				Weight (Kgs)			
Load-1 (KN)	Load-2 (KN)	Load-3 (KN)	Avg Load (KN)	W 1	W 2	W 3	Avg Weight
180	190	185	185	6.6	6.8	6.76	6.72

- **Avg Strength** :-185 KN = 185000 N
Compressive Strength: - Load/ Area of Cube
 $185000/22500$
8.22N/mm²

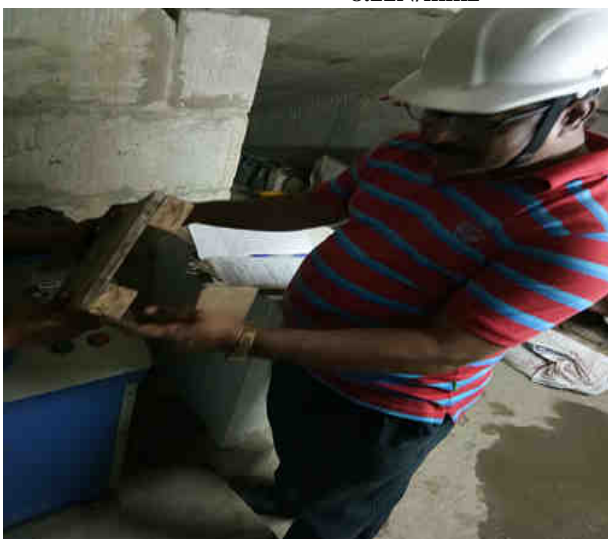
Figure.6 Compressive test carried out on Skin wall Sample

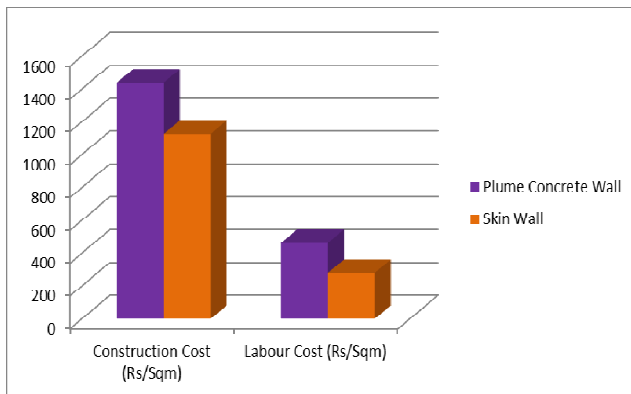
Figure.7 Graphic comparison between PCW & SW with respect construction cost, Labour Cost, Compressive test & Duration.

(A) Cost Difference between Plume concrete wall & Skin wall (Material + Labour)	Rate	Unit	Percentage
(a.1) Cost of Plume concrete wall construction (Avg thickness of 200mm)	1654/-	Rs/Sq.mtr	100%
(a.2) Cost of Skin wall Construction	1266/-	Rs/Sq.mtr	74.55%
Difference of Rate Between PCW & SWC	313/-	Rs/Sq.mtr	25.45%
(B) Labour Rate Difference between Plume concrete wall & Skin wall			
(b.1) Labour Rate for constructing plume concrete wall construction	414/-	Rs/Sq.mtr	100%
(b.2) Labour Rate for constructing Skin	280/-	Rs/Sq.mtr	67.63%
Difference of labour Rate Between PCW & SWC	134/-	Rs/Sq.mtr	32.37%
